# Short Comings of Conventional Vibration Monitoring

Commissioning: 1999  
Power: 42 MW  
Speed: 112.5 rpm

Turbine Type: Bulb / Kaplan  
Nbr Blades: 4  
Bearing Layout: Generator Guide  
Turbine Guide

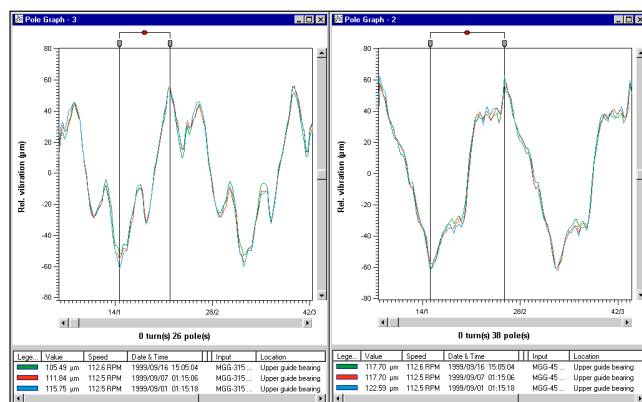
Comparison of vibration results for the same period showed that no significant change had yet been measured. Pole measurement graphs in Figure 1 indicate that the overall shape of each sensor curve remained similar while the amplitude slightly increased. Peak-to-peak vibration levels for all probes were still within or slightly above normal assembly tolerances<sup>2</sup>. Further analysis of FFT and orbit graphs (Figures 2 and 3) did not show significant variations over the same period.

Figure 1: Comparison of shaft displacement measurements at Generator Guide Bearing (left: Y / 315°, right: X / 45°) taken on September 16th, nine days earlier, and two weeks before. Note how little the curves have changed: X varied from 105 to 115 µm and Y varied from 117 to 122 µm.

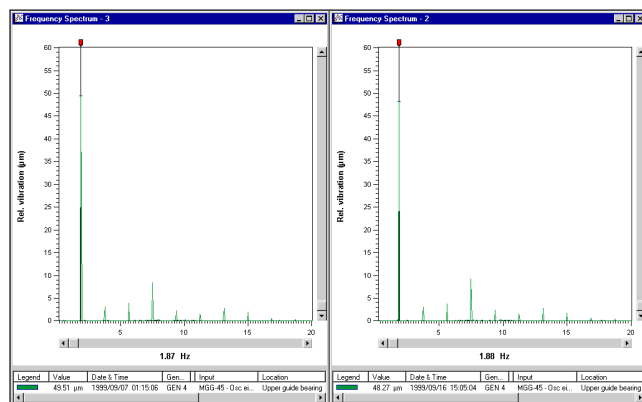
Figure 2: Frequency Spectrum graphs comparing FFT results of X (45°) axis probe at Generator Guide Bearing between September 16th (right) and nine days earlier (left). Again, the spectrums are very similar in amplitude and frequency.

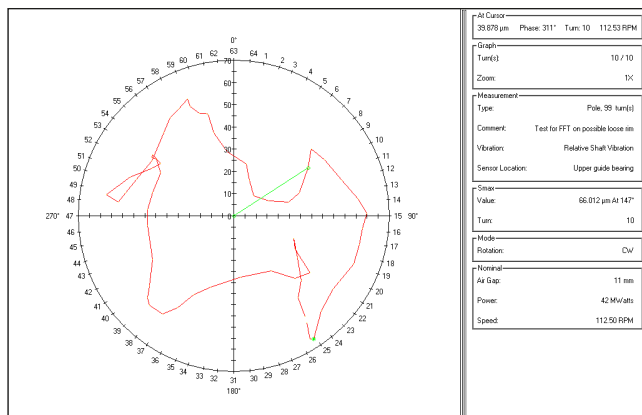
Figure 3: Typical shaft orbit at Generator Guide Bearing on September 16th. The cursor indicates the position of the shaft when pole #39 (most critical) faces air gap sensor at 225°.
