# Detecting High End-winding Vibration to Prevent Failure

## Machine Data

## VibroSystM Inc. and Dixtech Engineers India

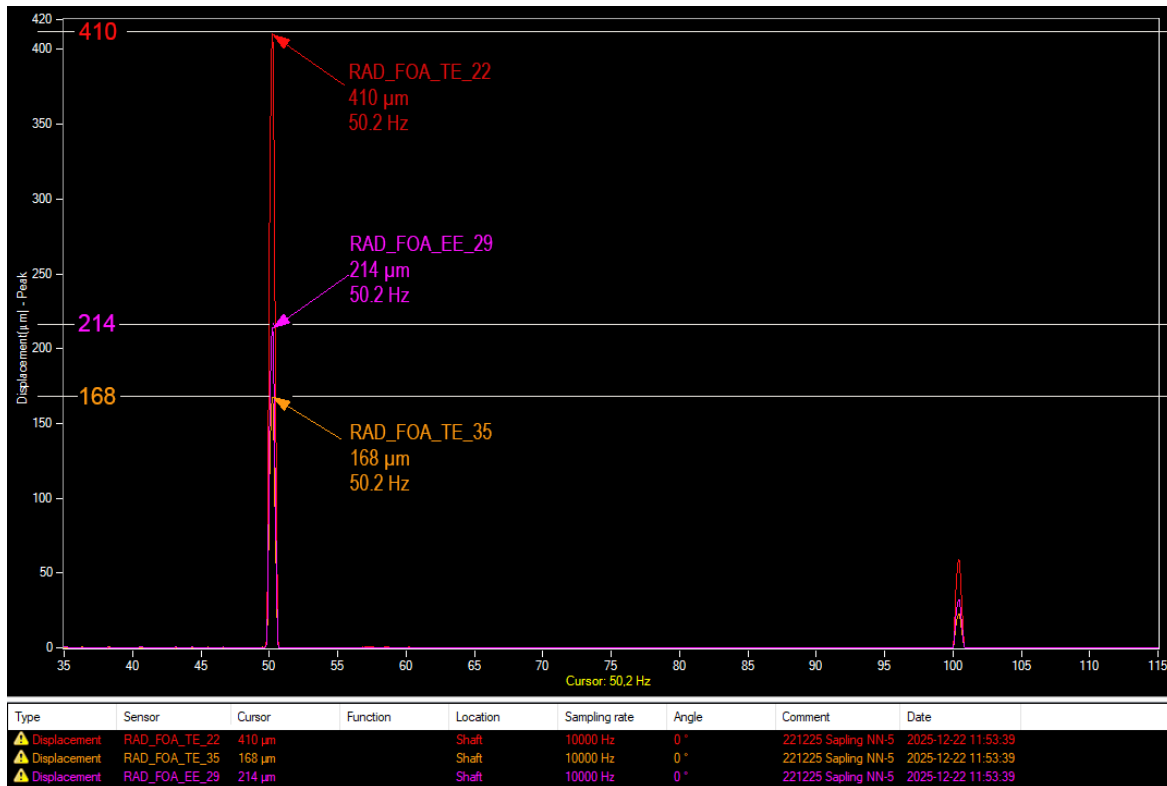
Normally, the primary vibration frequency of a machine's end-windings is double that of the grid frequency (which is also the rotational frequency). For example, for a 50Hz grid frequency, the main frequency of the end-windings would be 100Hz. In this case, the primary vibration frequency on many channels matched the grid frequency. Three channels showed consistent elevated levels including one peaking above 400  $\mu\text{m}$ . For a machine of this class, 400  $\mu\text{m}$  at 50Hz represents extreme mechanical energy. While 100Hz is expected due to the electromagnetic forces at work, a dominant 50Hz peak suggests the end-winding structure is no longer rigid and is responding to the rotor's residual mechanical forces.

**Fig. 1 - FFT of the sensors showing the highest vibration amplitude at 50Hz frequency**

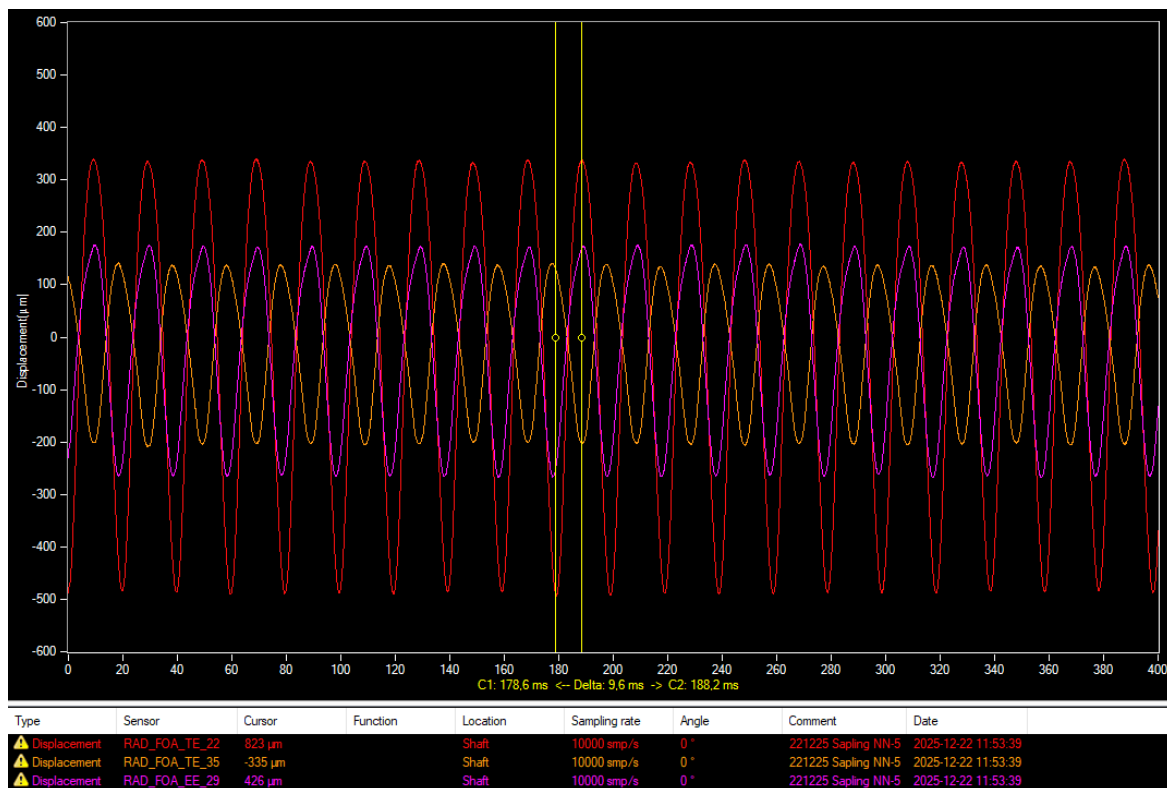
**Fig. 2 - Waveforms of the same 3 sensors showing consistency**

The time waveform shows a consistent, high-amplitude sinusoidal pattern. The lack of modulation indicates a permanent structural looseness or a resonance condition rather than a transient operational spike.

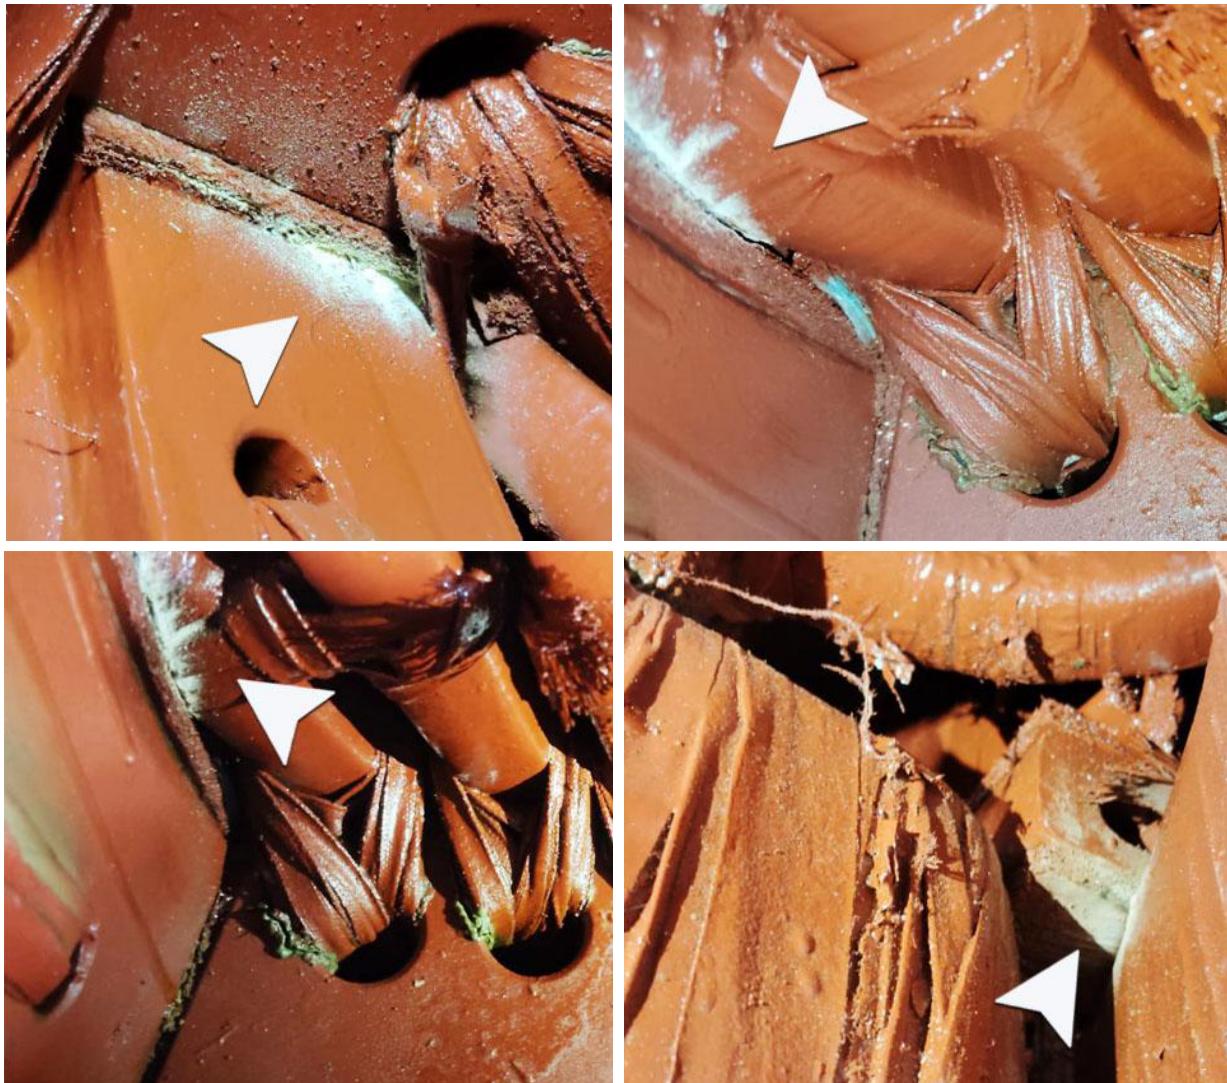
The FOA sensor data provided an internal view, which was subsequently confirmed by a physical visual inspection. They found significant white dusting or powdering on the spacers and winding surfaces in the critical areas identified by the FOA results.

This powder is the byproduct of insulation abrasion. As the bar vibrates, the mica-tape insulation rubs against the support bracing. The resulting dust is essentially the sanding down of the generator's primary dielectric protection.

The correlation between the highest recorded FOA displacement and the heaviest concentration of dusting confirms the system's accuracy in identifying the exact location with the highest mechanical degradation.

***Fig. 3 - Evidence of white dust found on spacers, bracing and winding surfaces where the highest vibration was detected***

1. **Targeted Structural Reinforcement:** Perform a detailed inspection and re-wedging/re-lashing of the end-basket, specifically focusing on the zones where white dusting was identified.
2. **Stiffness Analysis:** Conduct an offline Impact Test (Bump Test) to map the natural frequencies of the end-windings. The goal is to shift the structural resonance further away from the 50Hz/100Hz operating zones.
3. **Post-Intervention Validation:** Have an RIS diagnostic report produced immediately following the first start-up post maintenance to verify that the overall vibration has been decreased to an acceptable level.
4. **Long-Term Trending:** Have periodic RIS update reports produced to identify potential creep in vibration levels as the machine cycles thermally.
