# Stator Thermal Expansion Analysis Boundary Dam Power Plant Unit U51

Authors : Casey Holter, P.E., Mechanical Engineer - Eng. & Tech. Ops, Seattle City Light  
David Elwood, P.E., Turbine/Generator Engineer, Hydro Power, GE Vernova  
Enzo Cloutier, Service Director, VibroSystM

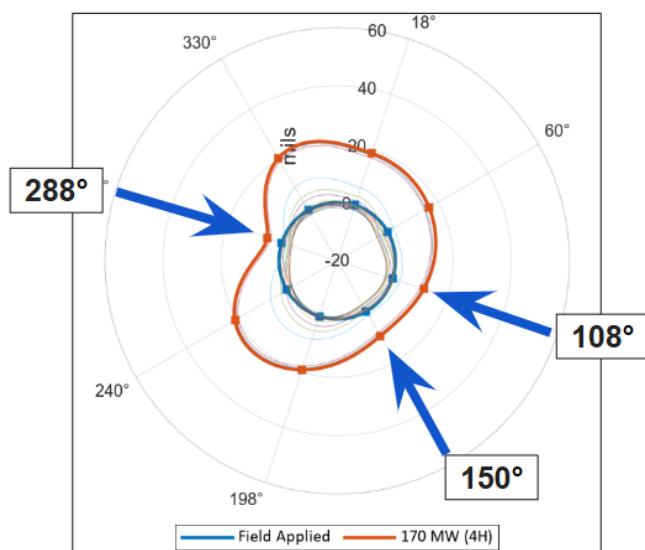
**Stator frame expansion in 2021**

The frame expansion was not proportional to the stator core expansion, averaging at 15.5 mils for the Stator Frame compared to 28.5 mils for the Stator Core.

The locations with the least expansion for the Stator Frame were 108°, 150° and 288° indicating a sole plate issue at these locations.

At 288°, the expansion of the Stator Frame is especially low when compared to the expansion of the stator core at this location.

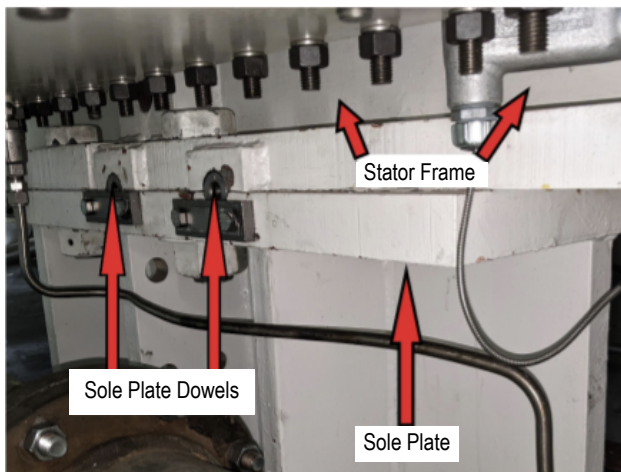
**Fig 2 - Stator sole plate**

Inspection was performed on the sole plates to confirm that they are be separated to the stator frame, cleaned and lubricated. Also a means must be provided to allow installation of lubrication in the future.

Visual inspection of the dowels for galling was performed. Dowels should be checked during routine maintenance outages to ensure they can be pulled in freely and are not seized. For any dowels that are seized, machine dowel OD (outer diameter), minimum material removal to achieve proper clearance.

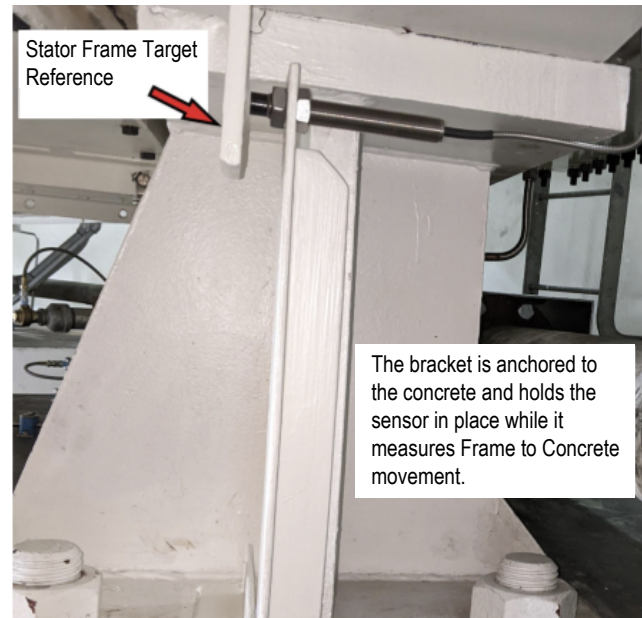
**Fig 3 - Stator frame displacement probe located at the sole plate**

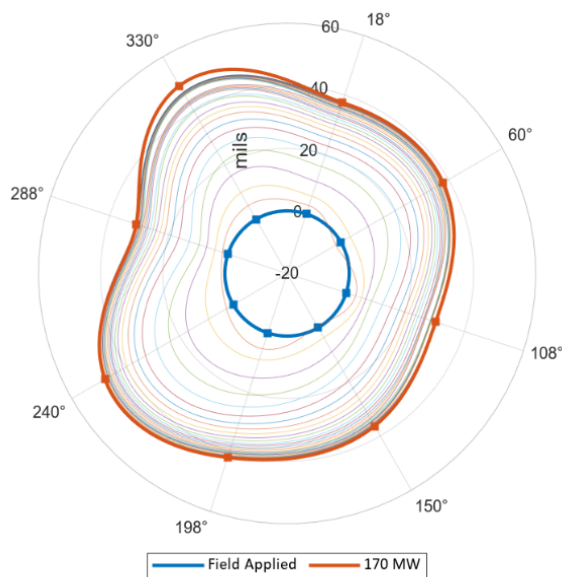
***Stator frame thermal expansion in 2024***

Following the maintenance, another heat run was conducted in 2024. The results showed significant improvement in the stator frame expansion, which was now proportional to the stator core expansion and more uniform overall. The average expansion for the Stator Frame has increased significantly at 38.9 mils. It now exceeded that of the stator core currently at 35.6 mils. Also, the Stator Frame expansion at 288° has improved from 7 mils in 2021 to 31 mils in 2024. As a result, the stator core expansion is also much more uniform, indicating that the maintenance had successfully addressed the issue.
