# Avoiding major damage on a new hydrogenerator by monitoring air gap at Igarapava H.E.P.P.

Authors: *Raimundo Jorge Ivo Metzker*, CEMIG  
*Marc R. Bissonnette*, VibroSystM  
*André Tétreault*, VibroSystM  
*Jackson Lin*, VibroSystM

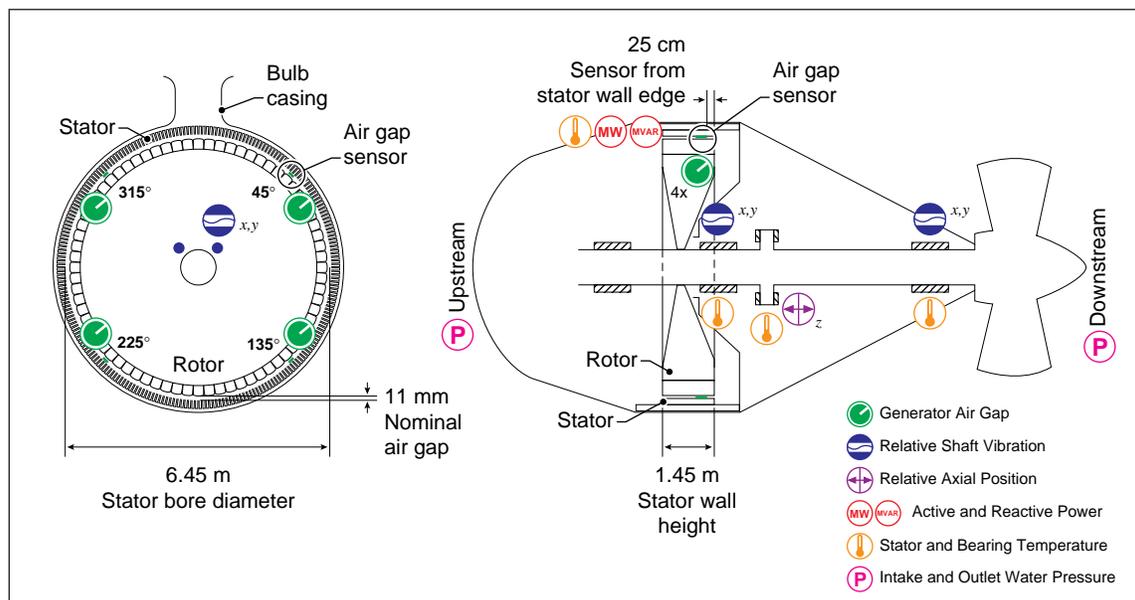
A total of four air gap sensors are installed on the perimeter of the stator core approximately 25 cm (or 10 inches) from the edge of the stator iron. Sensors are installed at the 45°, 135°, 225° and 315° locations (see **Figure 1**).

**Figure 1: Cross-sections of bulb unit showing air gap sensor locations on stator wall plus other monitored parameters.**

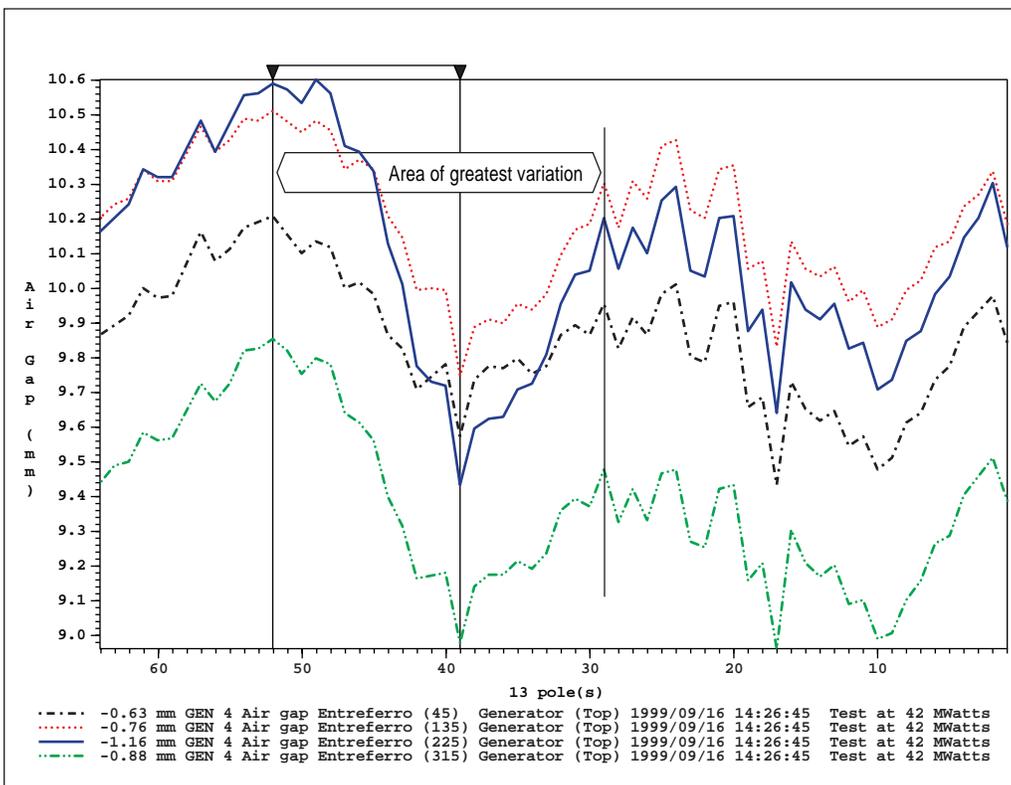
By isolating the signature of each of the four air gap sensors, it was possible to identify if the bump was permanent or transient (see **Figures 2 and 3**). A permanent bump would result in all four air gap sensors seeing the same signature trace. A transient bump would result in all four air gap signals showing a different trace. By using the ZOOM software, it was possible to determine that the bump amplitude varied depending upon the angle to which the rotor was turned. The maximum bump amplitude (or most critical air gap) occurred when rotor pole #39 passes in front of the 225° sensor.

Figure 3: Air gap signatures of all four sensors at full load (42 MW). Note the dramatic shape variation for 225° sensor between poles 52 and 29 compared with other sensors and with Figure 2.

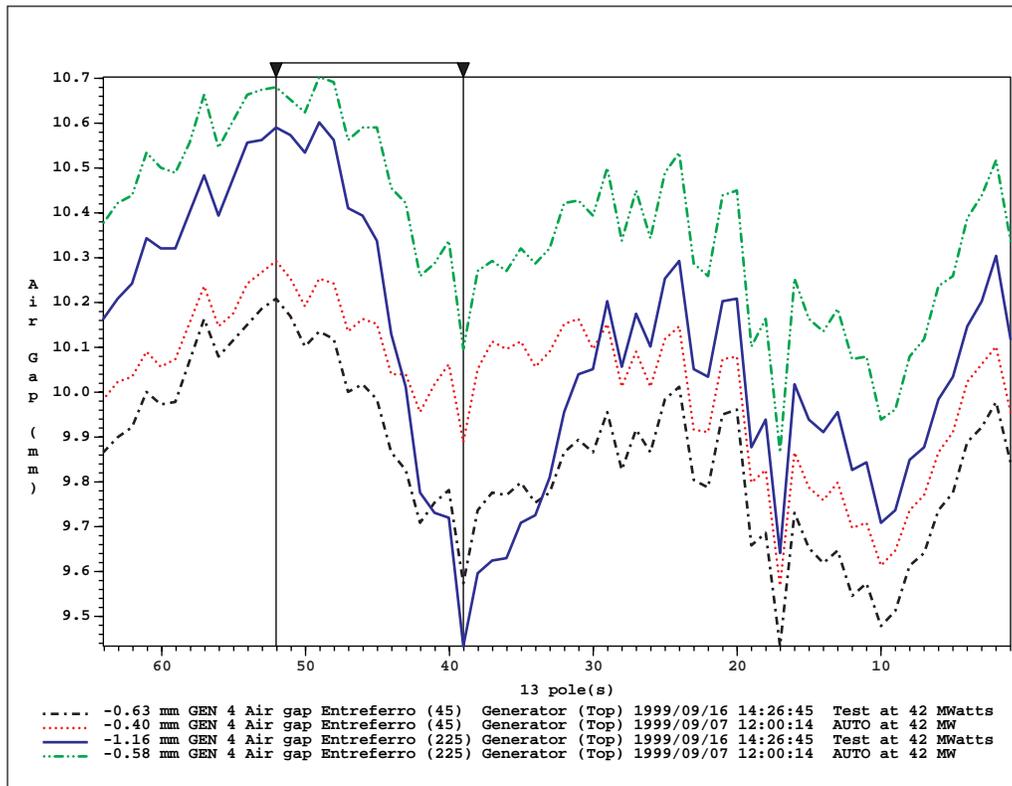
Figure 4: Air gap signature of opposite sensors at 45° and 225° showing rapid deterioration over a period of 9 days.

Table 1: Air gap differences for Pole 39 (location of greatest rotor rim movement) over a 9-day period

Sensor	Pole 39 / 42 MW (in mm)		
	Sept. 7 1999	Sept. 16 1999	Difference
45 deg.	9.89	9.57	- 0.32
135 deg.	10.17	9.74	- 0.43
225 deg.	10.10	9.44	- 0.66
315 deg.	9.37	8.98	- 0.39

VibroSystM plotted the 225° and 45° sensors and compared these with the same data from a week earlier. From the signatures of **Figure 4** and data of **Table 1**, it was clear that even over the course of one week, there was significant deterioration of the air gap. Polar views of generator in **Figure 5** compares rotor rim profiles under two operating conditions (i.e. S.N.L. and full load) and in **Figure 6** compares rotor profiles at 42 MW load taken 9 days apart (September 7 and 16, 1999).

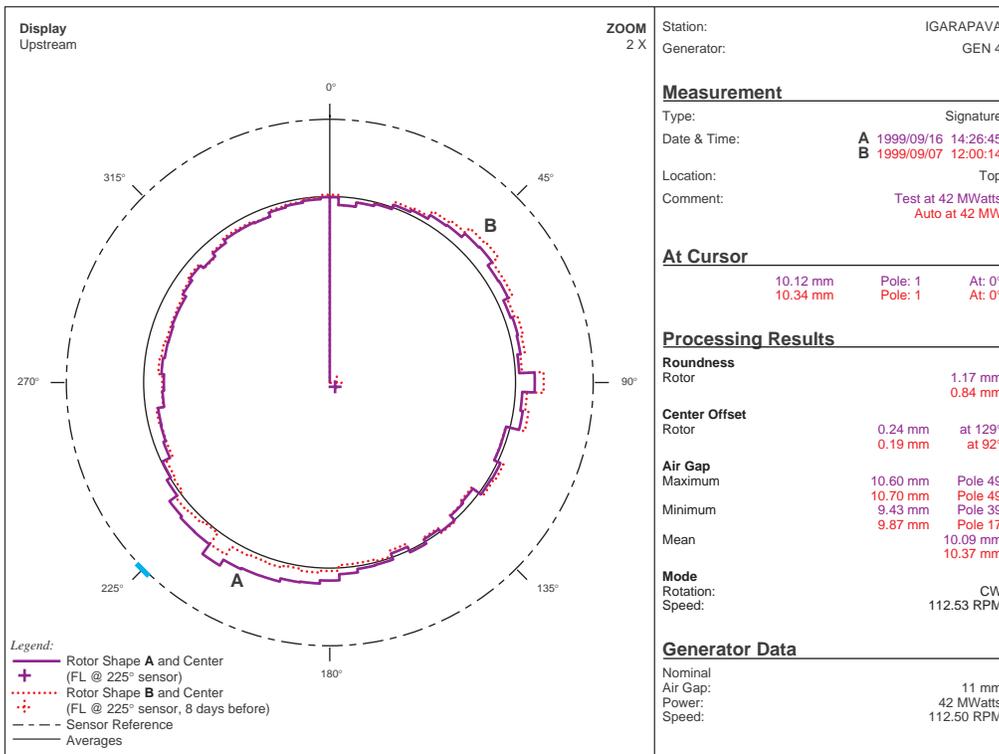
In studying the data, VibroSystM alerted CEMIG that the monitoring system clearly indicated a potential rotor-stator air gap failure could occur at any time.

**Figure 6: Polar view of generator comparing rotor shape deterioration over a period of 9 days (at full load of 42 MW).**

Realizing the gravity of the situation and the potential danger of the imminent rotor-stator contact, the CEMIG supervising engineer immediately contacted the CEMIG head office. From its Belo Horizonte headquarters, CEMIG engineers were able to remotely access the ZOOM data via their remote ZOOM controller and confirm that the danger of an imminent rub was real. The CEMIG engineers printed the relevant ZOOM plots showing the results and faxed them to the generator manufacturer's project office. Upon further study, CEMIG shut down the machine and requested the generator manufacturer to inspect the rotor rim.
