AIR GAP MONITORING SYSTEM KEY ELEMENT TO CORRECTLY DIAGNOSE GENERATOR PROBLEMS

ROLIM, Flavio, frolim@furnas.com.br, FURNAS, Rio de Janeiro, RJ (Brazil)
TÉTREAULT, André, techsupp@vibrosystem.com, VibroSystM inc., Montréal, Qc (Canada)
MARSHALL, Richard, techsupp@vibrosystem.com, VibroSystM inc., Montréal, Qc (Canada)

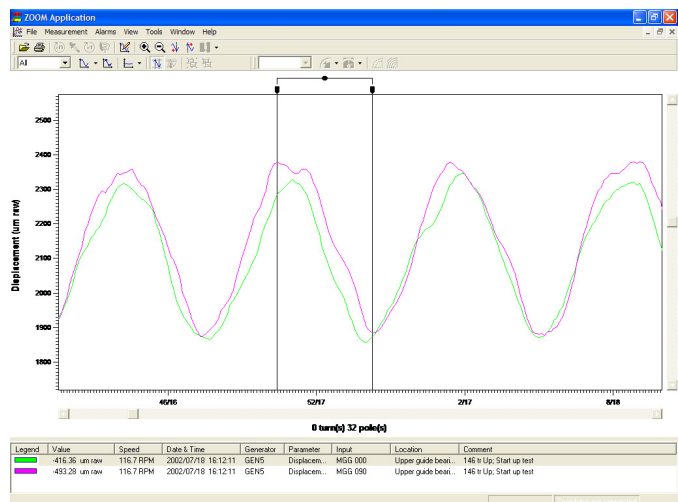
Figure 1. Speed No Load vibration readings. (See Figure 3 also).

We can see that the vibration readings for both axes were in the range of $\approx 500 \mu\text{m}$ pk-pk. However, the unit behaviour changed drastically with field excitation, especially in the 0° area located upstream. Vibration levels were high during start up but decreased significantly after excitation, as we can see in Figure 2.

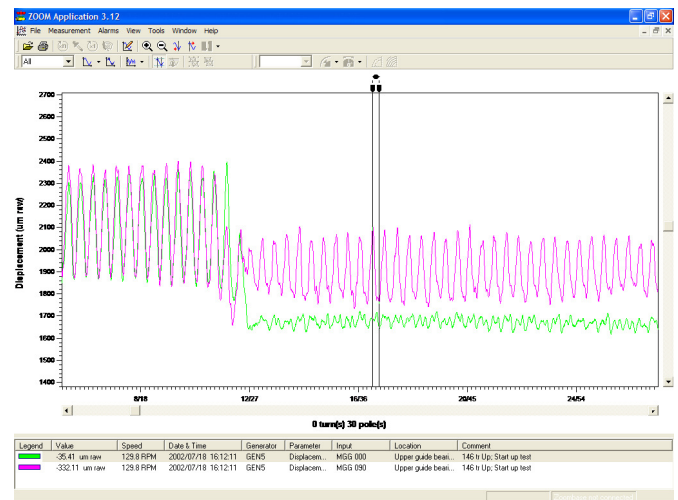
Figure 2. Vibration readings before and after field excitation. (See Orbit in Figure 3).

We can see that the vibration readings in the 90° axis have reduced to the range of $\approx 350 \mu\text{m}$ pk-pk whereas the vibration readings in the 0° axis have significantly decreased to a range of $\approx 50 \mu\text{m}$ pk-pk. Furthermore, we can easily observe a shift in the shaft position in the 25° upstream direction of $\approx 470 \mu\text{m}$ and. This shift is confirmed by tracing an orbit graph of the same measurement with the help of VibroSystM comprehensive diagnostic software. Figure 3 shows the shift towards upstream very clearly.

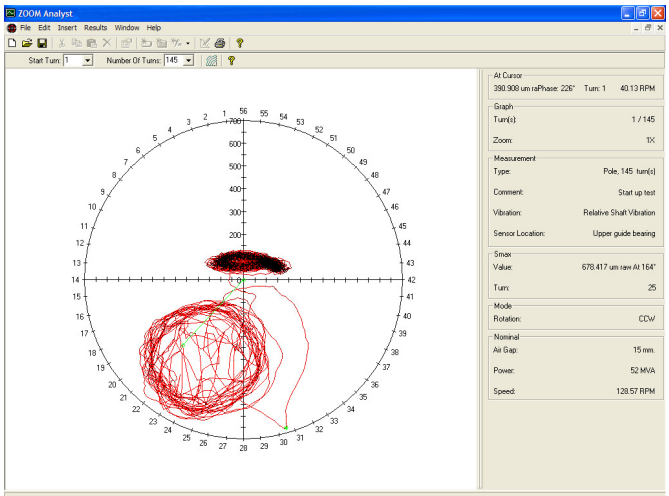
Figure 3. Orbit graph of start-up including field excitation at upper guide bearing.

The shift was thus established but not its cause. Troubleshooting this problem with the sole information provided by a vibration monitoring system is, at best, extremely difficult.

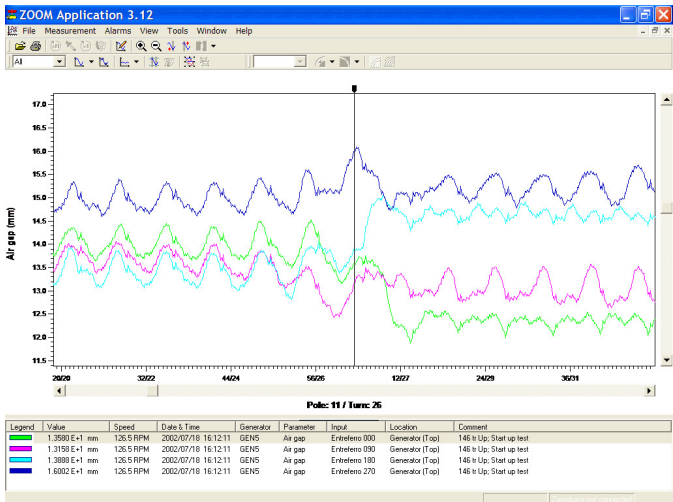
Figure 4. Air gap readings during start-up.

The graph shown above is a representation by VibroSystM software of the minimum air gap reading of each individual pole for each of the four air gap sensors. Each coloured curve represents one air gap sensor with a representation of the passing rotor poles for a certain number of rotations.

In the case under study (as shown in Figure 4), we can see that the greatest decrease in the air gap is not recorded at the location where the air gap is initially the smallest (180°) but at the opposite location (0°). The air gap at 0° decreased significantly (-2,24 mm) as well as at 90° (-1,18 mm) while the air gap decreased only slightly at 270° (-0,30 mm) and increased at 180° (+ 0,80 mm). These values were obtained from VibroSystM software which calculates the average air gap of each sensor during one rotation. The increase in air gap at 180° is caused by the rotor shift toward the 25° upstream direction which was close to 470 μm as recorded by the shaft displacement sensors. If the unit is not behaving as expected, then some other factor must be influencing its behaviour.

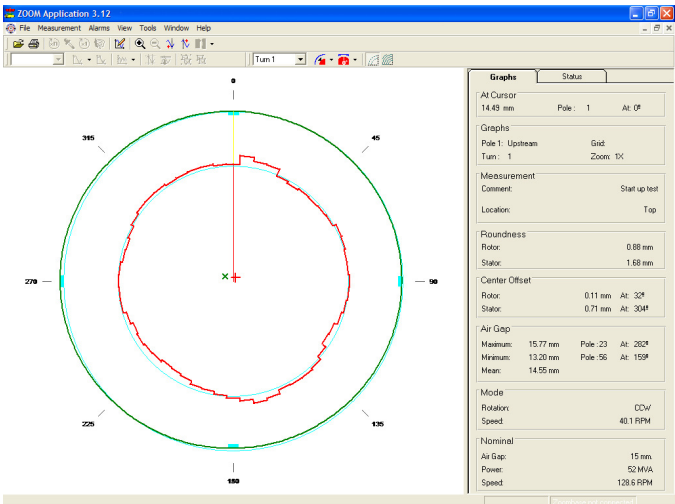
Figure 5. Polar graph of rotor/stator before field excitation.

Figure 5 shows the state of the rotor and stator before excitation while Figure 6 shows the state after field excitation.

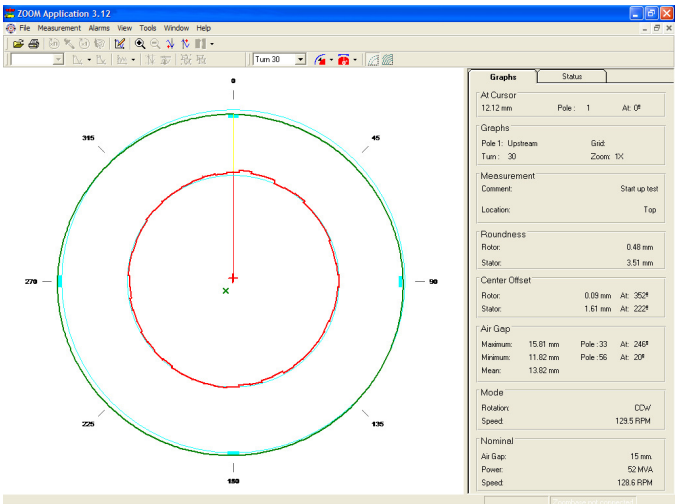
Figure 6. Polar graph of rotor/stator after field excitation.

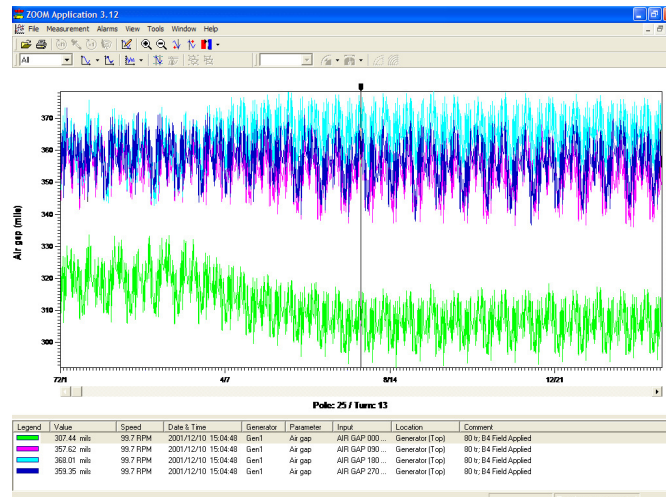
Figure 7. Example of an air gap behavior during excitation on an off-centered rotor-stator creating an uneven air gap.

In this example, we can clearly see that before excitation, the smallest air gap is found in the area of 0° upstream as recorded by the air gap sensor at that location. When the field is applied, the air gap decreases at a higher rate in that area than at the other locations (0° , -400 μm ; 90° , -180 μm ; 180° , +165 μm ; 270° , -140 μm) because the magnetic forces are greater there than elsewhere causing greater stress on the rotor rim and on the stator core as well. As we would expect, the air gap at the opposite side (180°) increases slightly because of the shift towards upstream. By producing a Polar Graph (VibroSystM software representation of the rotor/stator shape for one rotation as seen by the air gap sensors) we can see the small air gap at 0° as shown in Figure 8.

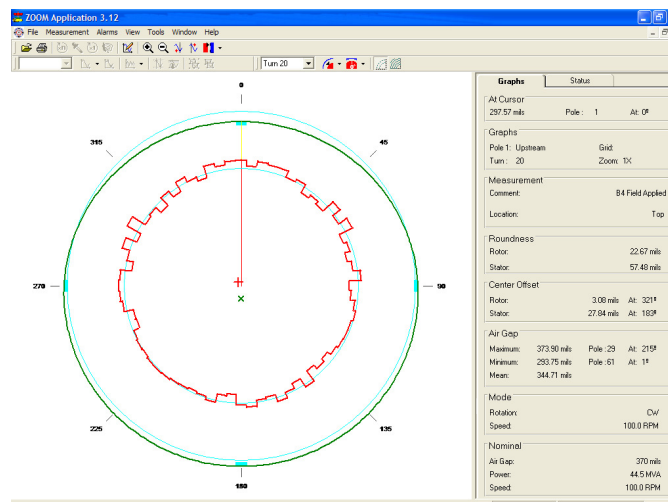
Figure 8. Polar Graph of rotor/stator after field excitation for generator in Figure 7 example.

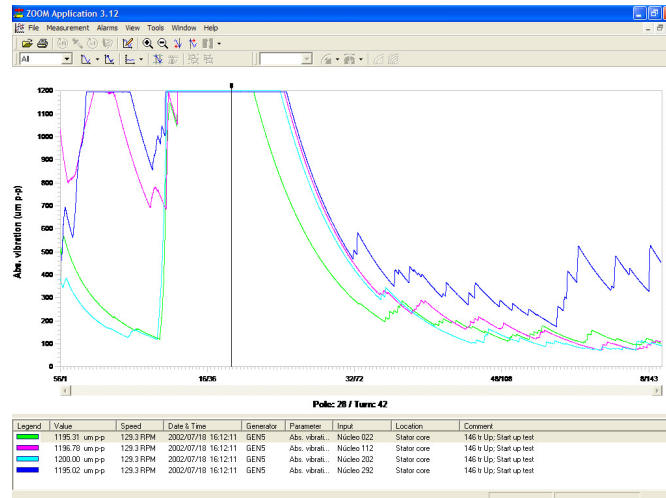
Figure 9. Stator core vibration during field excitation.

The data represented in this graph was obtained via a PCU-100 instrumentation rack processing the acceleration signal into a pk-pk displacement reading. The vibration is so high that it exceeds the accelerometer 1200 μm pk-pk range on all four transducers. This excessive vibration is caused by the flexing of the stator in the downstream direction. To confirm this phenomenon, stator displacement sensors should be added all around the stator at 90° intervals, preferably behind air gap sensors or accelerometers to facilitate their correlation. To further corroborate our assertion that the stator is encroaching at 0° when the field is applied, we have verified the stator behaviour as the unit heats up. We observe in Figure 10, which shows a measurement taken at normal operating temperature five days later, that the stator slowly shifts back close to its original position due to the thermal expansion and regains a better roundness.

The Unit was stopped again to resolve the discovered problem and other issues. The stator was moved 1,0 mm upstream in an attempt to improve the Unit behaviour. Although this procedure helped in decreasing the shaft vibration values when the field was applied, the major problem remained. The Unit still experienced instability when the Unit was at Speed No Load (with field applied) condition. The Unit would experience significant change in its behaviour when the field was applied and would see an increase in the shaft vibration values after time. So far, four Units (Units #5 to #8) have been refurbished and all of them have experienced similar behaviour. Two Units (#6 and #7) have been shutdown for almost a year waiting for a solution from the manufacturer. Units #5 and #8 have experienced similar behaviour however, the problem is not as severe (although the Units performed better before being refurbished) and both Units are in operation at this time. The manufacturer is studying the problem and believes that it is related to the upper guide bearing stiffness. One of the major parts of the refurbishment project was to upgrade the stator insulation from class B to class F. The Unit stators were comprised of four bar circuits prior to the modifications. With the change in insulation, the manufacturer introduced a one bar circuit approach, which increased the magnetic pull, without re-designing the upper guide bearing stiffness. This could explain the erratic behaviour of the Units. The manufacturer is now planning to reinforce the upper bracket, which supports the upper guide bearing, to increase the bearing stiffness. The upper bracket is bolted to the powerhouse concrete. This modification is expected to be implemented no later than next December.

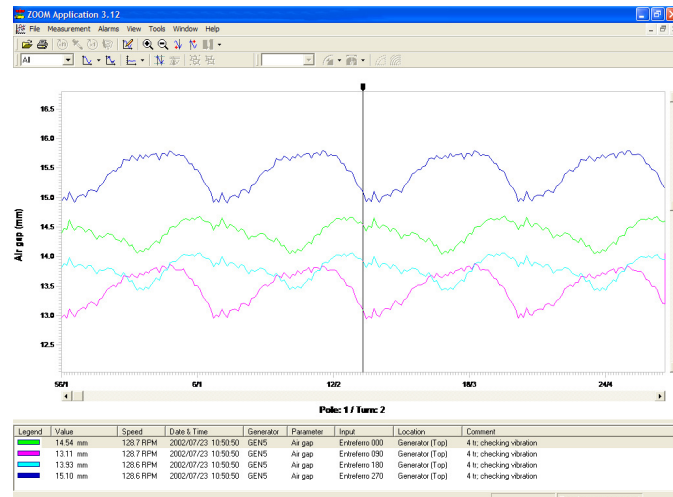
Figure 10. Air gap after thermal expansion of the stator.

The air gap at 0° increased by 2,07 mm while at 90° , it increased by 0,41 mm. The air gap at 180° decreased by 0,90 mm which confirms the stator shift in an upstream direction. The air gap at 270° remained stable with a slight increase of 0,23 mm. Once again the values were obtained from VibroSystM software which uses the average air gap at each sensor during one rotation. It is also interesting to note that at the same time, as shown in Figure 11, the vibration at the UGB 0° increased from $\approx 50 \mu\text{m}$ pk-pk to $\approx 170 \mu\text{m}$ pk-pk while the vibration at the UGB 90° decreased from $\approx 280 \mu\text{m}$ pk-pk to $\approx 130 \mu\text{m}$ pk-pk. Seeing that the stator moved back in the upstream direction and improved its circularity, the magnetic stress on the rotor in the area of 0° decreases thus allowing the rotor greater movement in the 0° - 180° direction and less movement in the 90° - 270° direction.

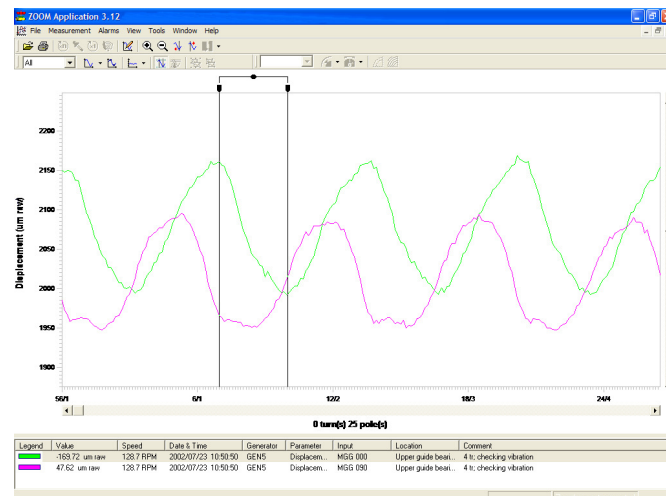
Figure 11. Vibration variation after thermal expansion of the stator.

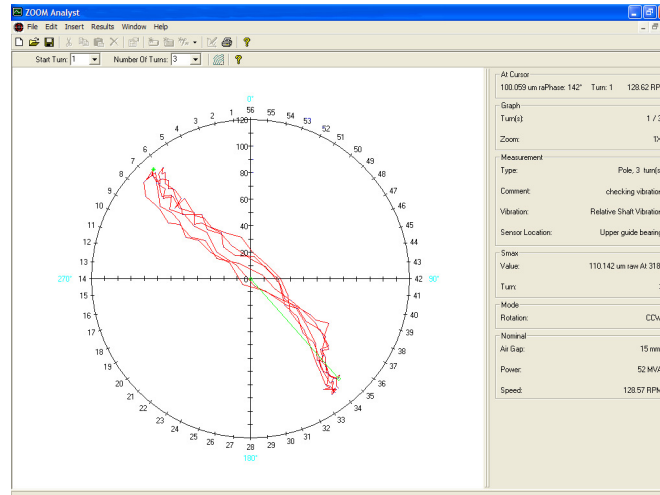
We can also observe the drastic change in the shaft displacement using an Orbit graph as shown in Figure 12.

Figure 12. Orbit of Upper Guide bearing displacement after thermal expansion of the stator.
