## **ON-LINE MONITORING SYSTEMS AS USED BY ELETRONORTE AT THE TUCURUI II & COARACY NUNES POWER PLANTS**

**TÉTREAUULT, André,** [techsupp@vibrosystem.com](mailto:techsupp@vibrosystem.com), VibroSystM inc., Montréal, Qc (Canada)

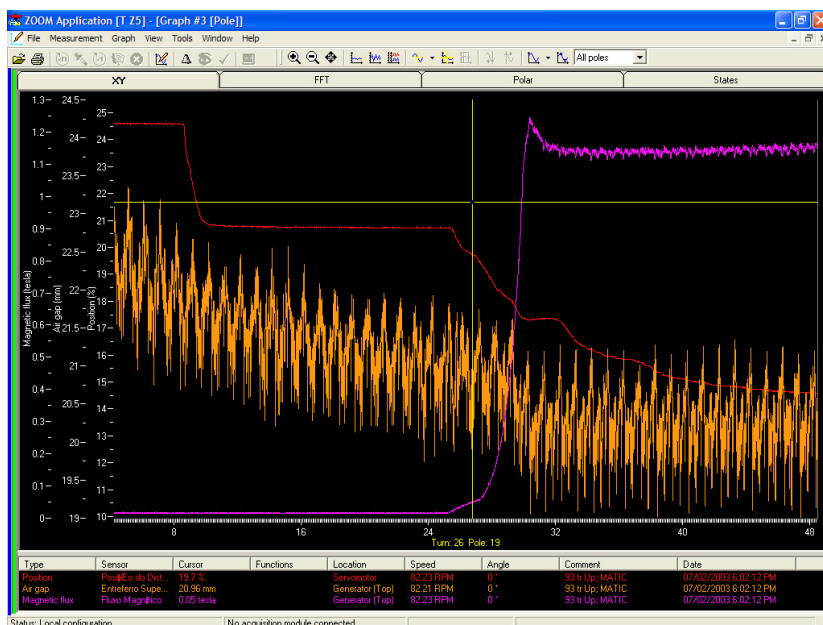
The ZOOM system was instrumental in verifying the air gap parameters necessary to determine the circularity/concentricity of the rotors/stators in relation to existing standards. Figure 1 shows the air gap as recorded by the capacitive sensors during a start up with field excitation. We can clearly see the effects on the air gap when the Unit speed increases and at the moment the excitation of the rotor occurs (magnetic flux is represented in purple). A sudden decrease of the air gap at all locations is quite noticeable. We can also observe that the Unit overshoots its nominal speed of 81.8 RPM during the start up.

Figure 1. Unit 13 Start up

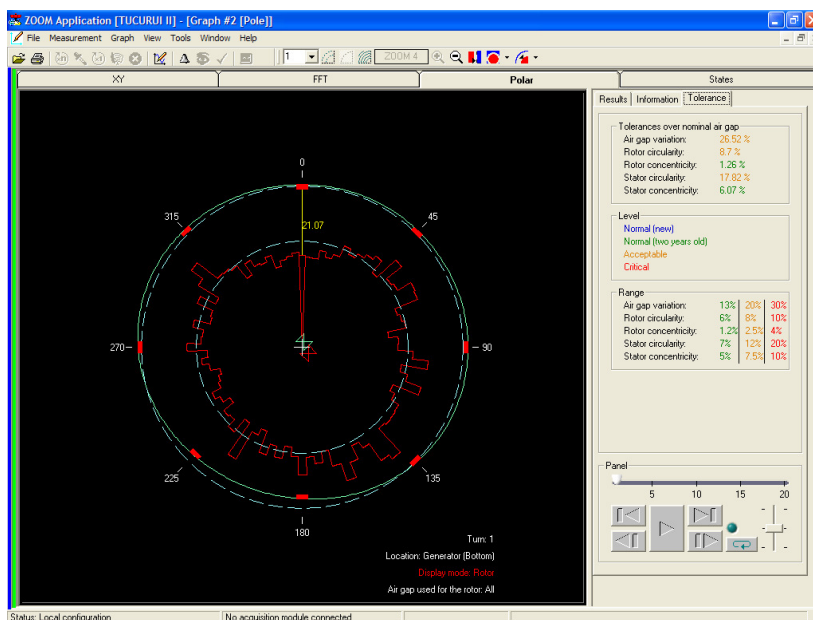
Figure 2. Unit 13 at 380 MWatts – Full Load

Measurements were recorded for the first 4 Units (Units 13 to 16) and only Unit 15 was found to have results which do not exceed existing CEA (Canadian Electrical Association) guidelines for a new Unit. Figure 2 shows Unit 13 at Full Load with a comparison to existing CEA guidelines displayed by the ZOOM software. We can see that the circularity values for both the rotor and stator exceed acceptable guidelines for a new Unit. Although the values are not alarming, these values should be monitored closely to identify any deterioration and perform an intervention if required.

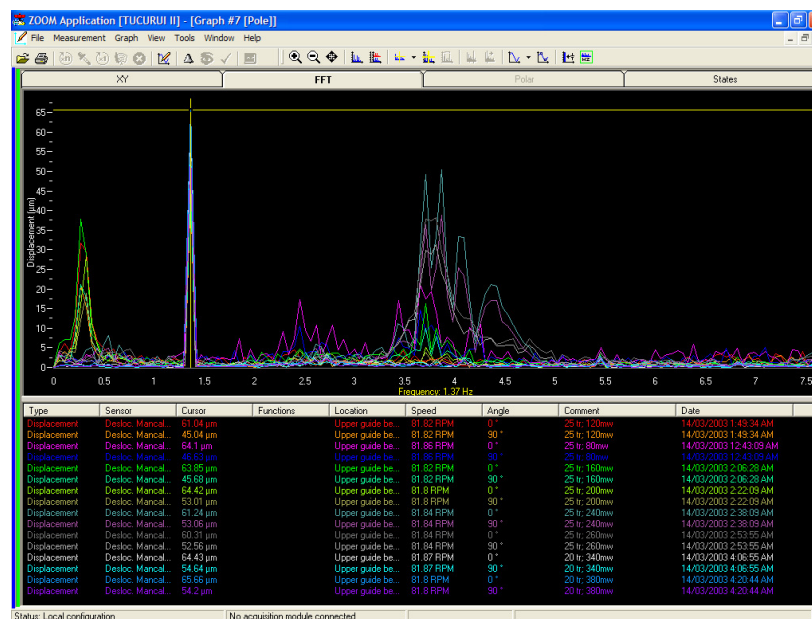
Figure 3. Spectral analysis at different loads – Upper guide bearing – Unit 13

Figure 3 shows the different frequency signatures according to the load as recorded by the two upper guide bearing capacitive sensors (PCS-202) installed at 90° X & Y angle. We can see that low loads, 120 – 160 MWatts for example, present frequency signatures at 0.3 Hz (1/5 the fundamental frequency for this Unit) while loads at around 260 MWatts have a distinct signature at  $\pm 3.8$  Hz (close to 3 times the fundamental frequency) and finally, all loads present a signature at the fundamental frequency for these Units which is 1.36 Hz ((120 poles/s)/88 poles). After analysis of all 4 Units (Units 13 to 16), it is apparent that all Units present the same frequency signatures at the upper guide bearing. Figures 4 and 5 show the orbit graphs for Unit 16 at three different load conditions (76 MW & 380 MW). We can clearly see the Unit settle down as the load increases. The orbit path stabilizes to a distinct circular pattern while the *SMax* (the maximum distance from the theoretical center) decreases significantly. At 76 MW, the *SMax* is 204 µm peak at 0° while at 380 MW; the *SMax* is 128 µm peak at 185°. The orbit graph provided by the ZOOM software can easily identify the heavy spot, which on Unit 16 was in the area of pole 85 at full load (380 MW). The orbit graph displays the actual position of the rotor poles

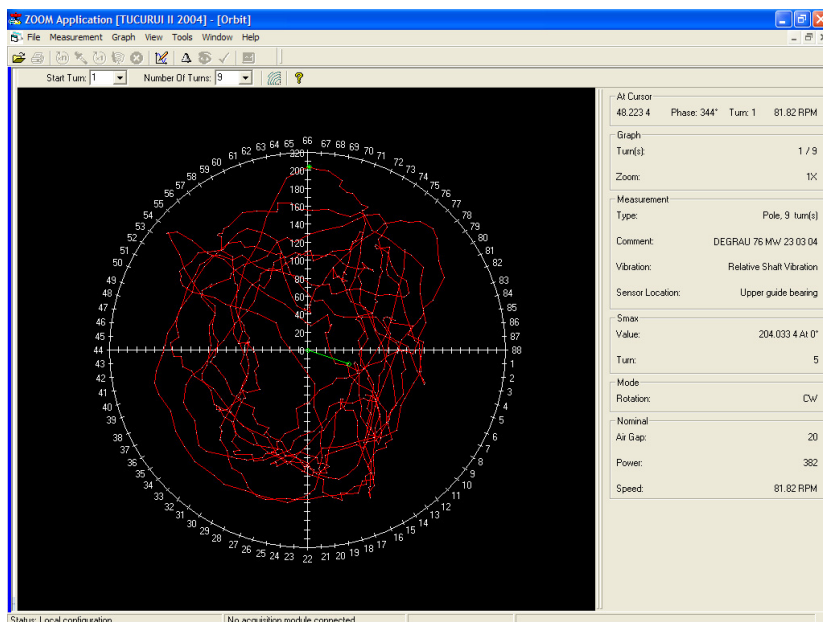
while the Unit is turning which provides valuable information in regards to the exact location of the heavy spot thus rendering balancing the rotor a much simpler process. In fact, during the commissioning of Unit 13, the VibroSystM service representative identified the heavy spot as being in the area of pole 43. The manufacturer informed the service representative that support brackets for weights had been left near that position. The Unit was stopped and the supports were removed.

Figure 4. Orbit of Unit 16 – Upper guide bearing - 76 MWatts

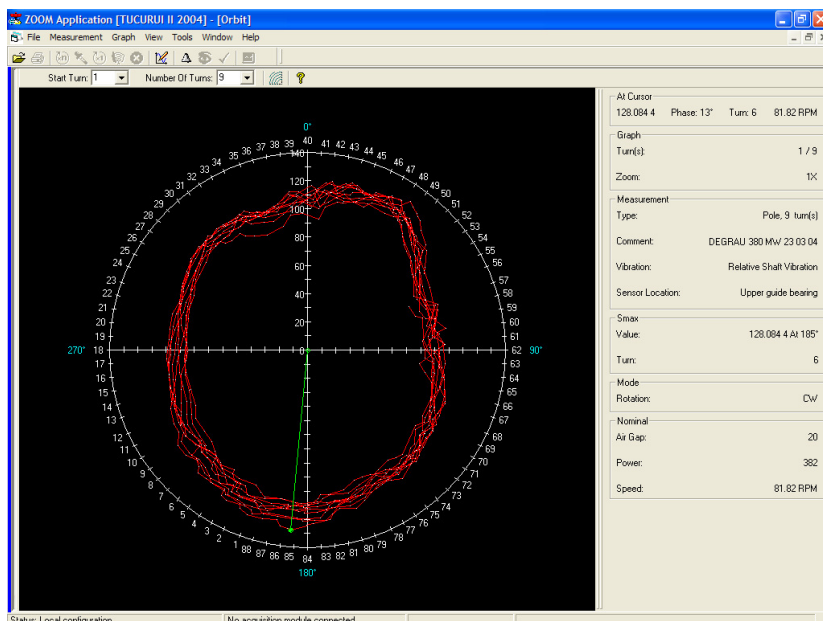
Figure 5. Orbit of Unit 16 – Upper guide bearing - 380 MWatts

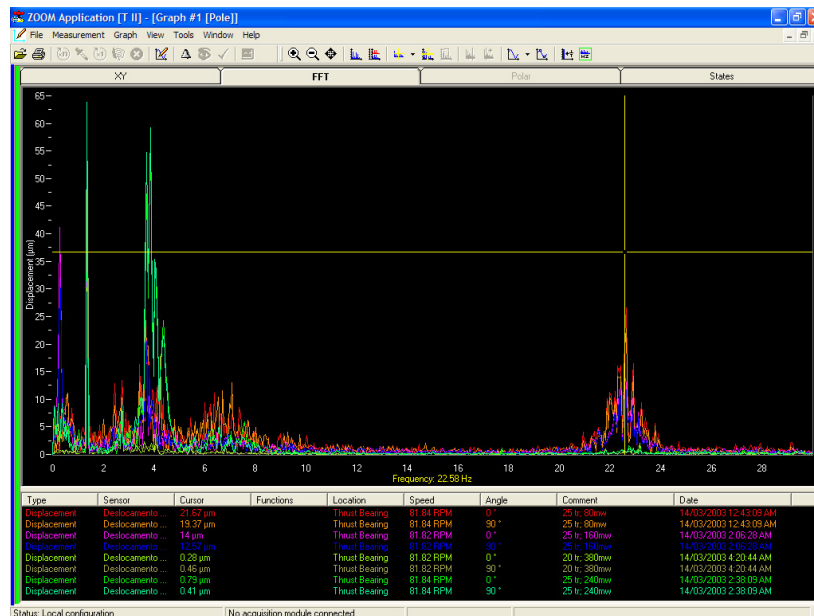
During the commissioning of all Units, radial vibration was recorded by two thrust guide bearing capacitive sensors (PCS-202) installed at 90° X & Y angle and there again, at small loads, vibration appears and slowly disappears in relation to the load increase. However, in the case of the thrust guide bearing, the phenomenon is located at a frequency of  $\pm 22.5$  Hz for all Units except Unit 14, which does

not experience any activity whatsoever in that frequency range. Figure 6 shows the frequency signatures of Unit 13 at various loads (Units 15 and 16 are quite similar) and figure 7 shows Unit 14's lack of activity.

Figure 6. Spectral analysis at different loads – Thrust guide bearing – Unit 13

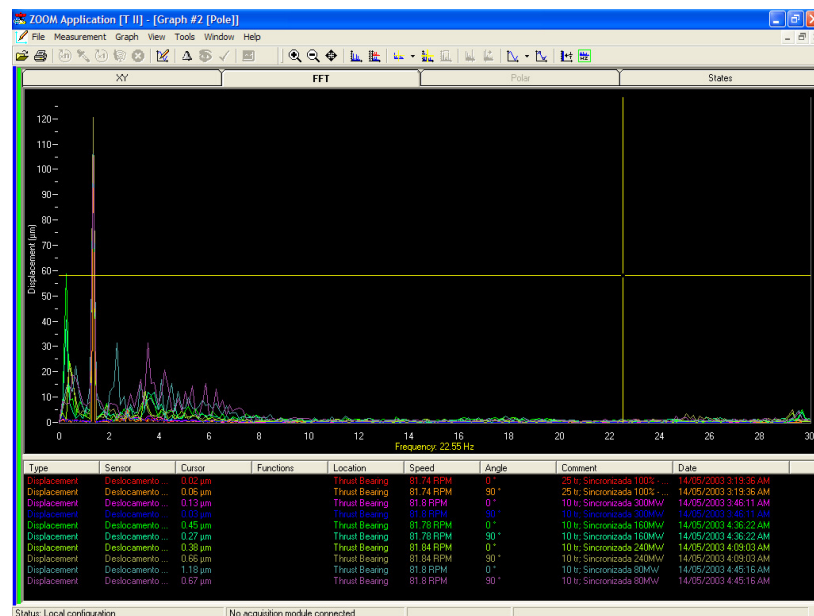
Figure 7. Spectral analysis at different loads – Thrust guide bearing – Unit 14

This phenomenon is caused by the fact that Unit 14 was designed by a different manufacturer than Units 13, 15 and 16 thus the displacement sensors at the thrust guide bearing were installed differently because of the thrust guide bearing housing. This installation was not possible for Units 13, 15 and 16 so the supports for these sensors were installed on the lower bracket which was designed differently. This is what we observe in the spectral graphs at  $\pm 22.5$  Hz. We can see in figure 8 that the absolute vibration at the thrust guide bearing confirms vibration activity which decreases significantly ( $\pm 14$  mm/s down to  $\pm 2$  mm/s) as the load is increased. Verification of the absolute vibration at the upper guide bearing revealed a similar decrease in vibration ( $\pm 5$  mm/s down to  $\pm 1$  mm/s) although smaller in scale.

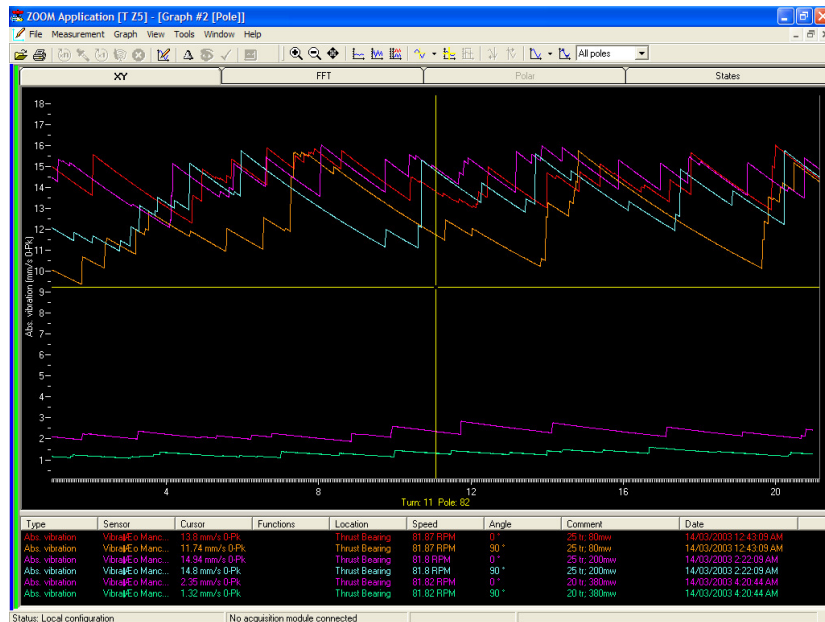
The turbine guide bearing sensors recorded a variation of  $\pm 12$  mm/s down to  $\pm 3$  mm/s. This behaviour was found to be similar on all four Units.

Figure 8. Absolute vibration – Thrust guide bearing – Unit 13

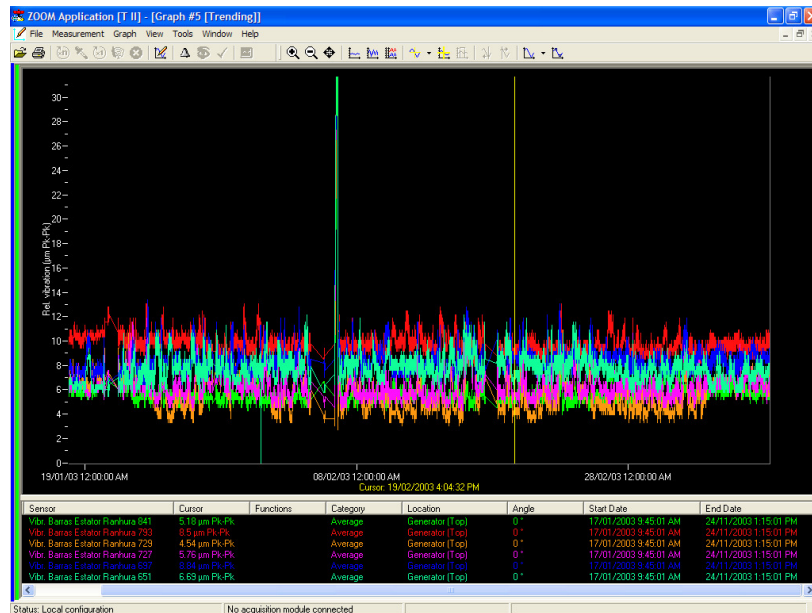
Twenty four capacitive stator bar vibration sensors (DCS-400) were installed at the upper part of the stator to monitor the vibration of the high voltage bars. These sensors were connected to an instrumentation rack (PCU-100) in order to process the signal into a peak-peak reading. During the commissioning stage, these vibration readings were recorded by the ZOOM system and found to be quite acceptable. In fact, the readings rarely exceeded 20  $\mu$ m pk-pk, which confirms the stator wedge tightness. Figure 9 shows a one month period of readings from the stator bar vibration sensors.

Figure 9. Trending graph of Stator bar vibration – Unit 13

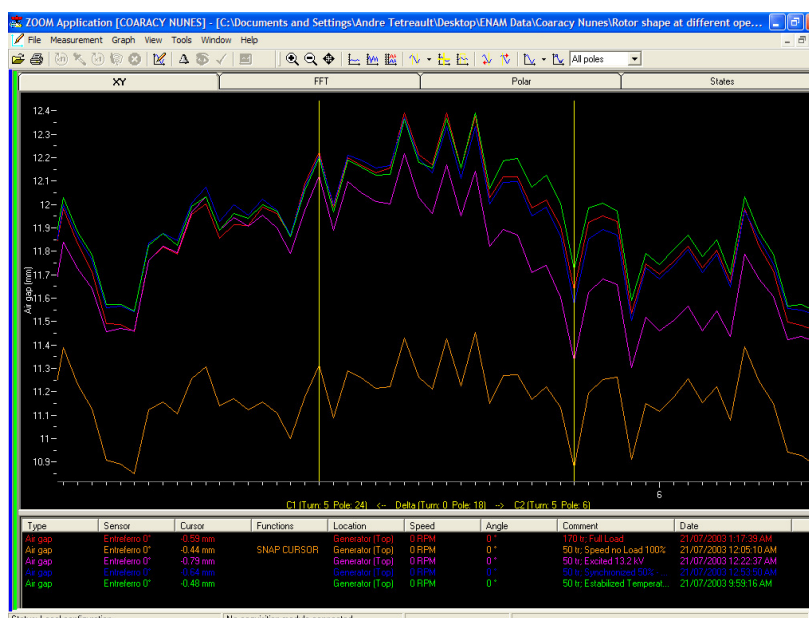
Measurements with the ZOOM system were taken in July of 2003 and the data was analyzed. The air gap sensors, installed at 90° intervals (0°, 90°, 180° and 270°) were able to record the position and shape of the rotor with the Unit at different operating conditions from Speed No Load up to Full Load with the temperature stabilized. This data showed quite clearly that the rotor suffered a displacement in the 180° downstream direction when the rotor is excited as shown by comparing figures 11 and 12. As the load increases, the rotor remains quite stable while the stator expands due to the increase in stator temperature. Figure 10 shows the air gap variation as seen by sensor 0° at 5 different operating conditions (S.N.L., Excited 0% MW, 50% MW, 100% MW and 100% MW fully hot).

Figure 10. Rotor shape and position evaluation

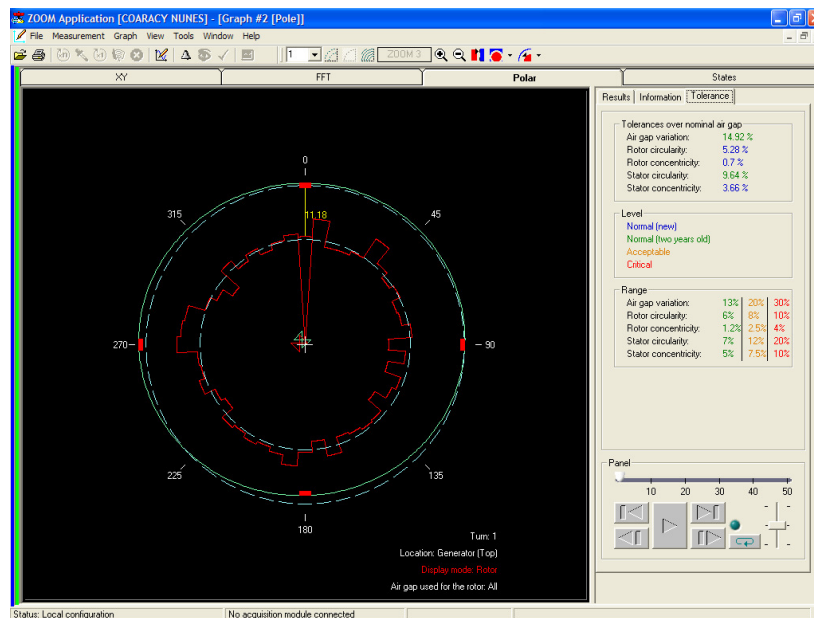
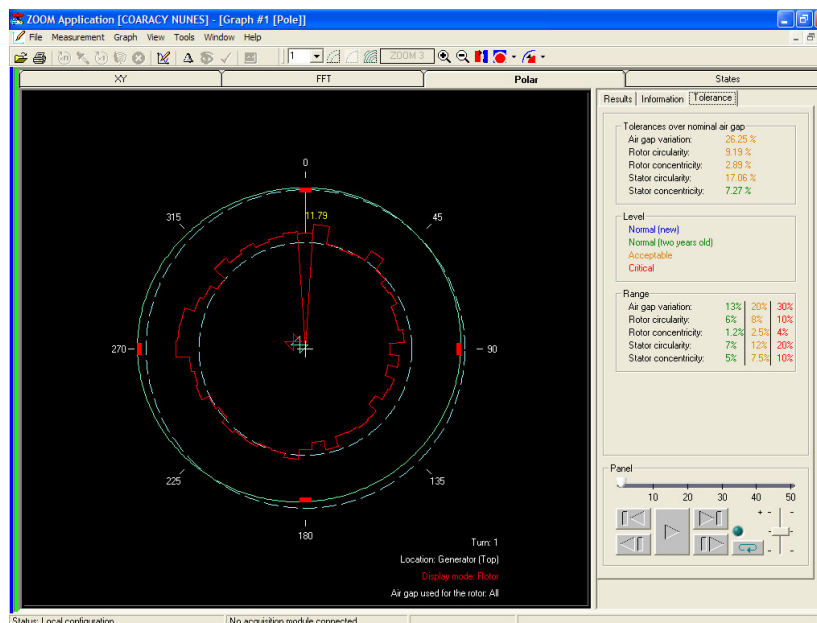
With the help of Figures 11 and 12, we can see that the rotor circularity is acceptable at speed no load while it slightly exceeds the CEA guidelines at full load. It is also possible to observe that some poles are protruding abnormally (especially poles 2 and 6). Usually, the difference between 2 successive poles should not exceed  $250\text{ }\mu\text{m}$ . This data can be used to investigate the pole to rim assembly and make sure that there are no discrepancies. The circularity of the stator experiences the same behaviour as the rotor which is to say that at speed no load, the values are acceptable. But at full load, the values exceed the CEA guidelines. Stator displacement sensors would be quite valuable in this case to confirm the stator behaviour.

Figure 11. Polar graph at Speed No Load

Figure 12. Polar graph at stabilized temperature

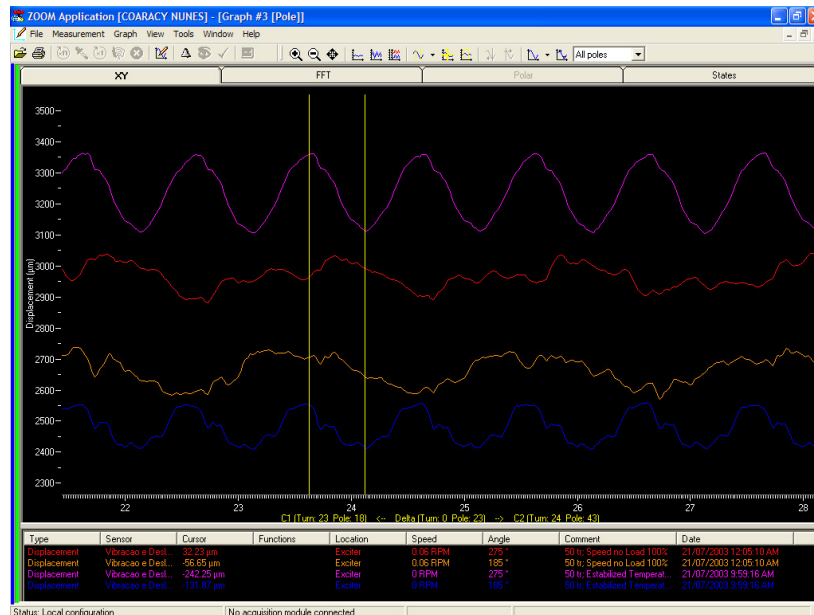
The data recorded during the testing showed that there was a sharp increase in the vibration once the field was applied. We can see this increase on Figure 13. However, the vibration decreases somewhat as the load is increased. It is interesting to note that the analysis software was able to show a particularly interesting phenomenon related to the vibration frequencies at Speed No Load compared to excited, all the way up to Full Load. Figure 14 shows a spectral analysis of the two vibration probes installed above the rotor (at the Kaplan oil head) recording data at the five operating conditions mentioned earlier in this paper. We can see that at Speed No Load, the predominant frequency is located at 1.2 Hz while as the load is increased, the predominant frequency shifts to 2.5 Hz, the actual mechanical fundamental frequency for this Unit.

Figure 13. Displacement - SNL @ Full Load

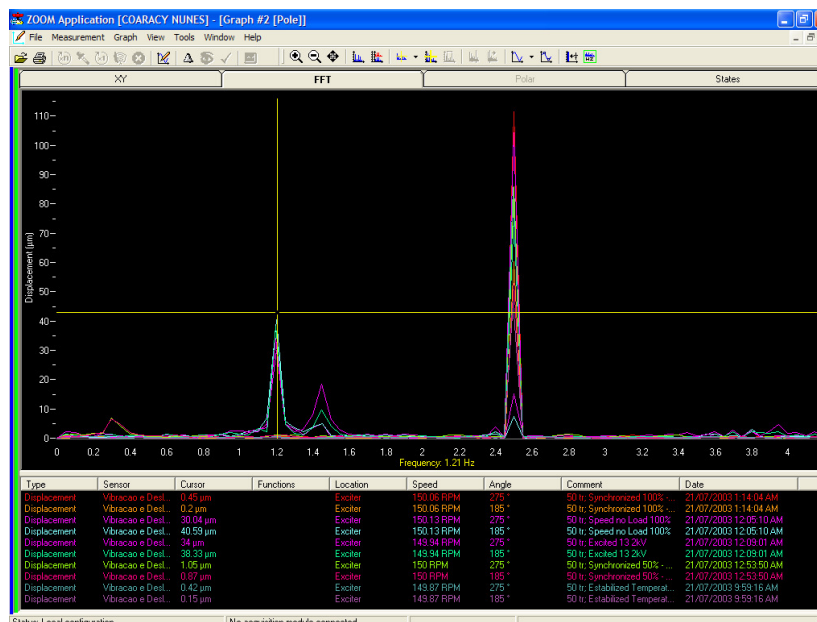
Figure 14. Frequency shift from 1.2 to 2.5 Hz
