AIR GAP MONITORING
KEY ELEMENT TO CORRECTLY
IDENTIFY SOURCE OF SHAFT VIBRATION

ANDRÉ TÉTREAULT

VIBROSYSTEM INC.

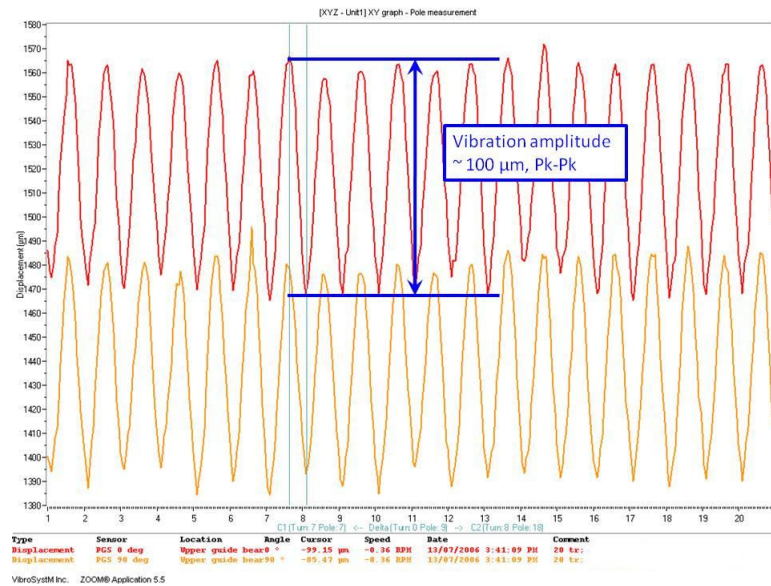
Figure 1. Upper guide bearing vibration at Speed No Load – No excitation.

Amplitude values of $\sim 100 \mu\text{m}$, Pk-Pk were quite acceptable, especially for a Unit that is operating at speed no load, without excitation. Typically, this is where hydrogenerators are most erratic basically because of the hydraulic forces exerted on the Unit, without the benefit of electromagnetic forces which usually settle the Unit down somewhat. *Figure 2* of the following page shows the amplitude values at the lower guide bearing under the same operating condition. We can see that the values were quite lower; in the range of $\sim 30 \mu\text{m}$, Pk-Pk.

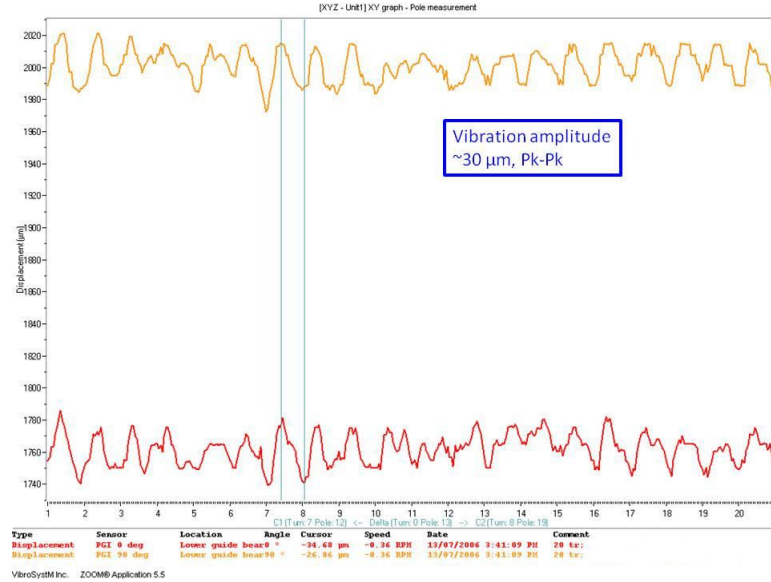
Figure 2. Lower guide bearing vibration at Speed No Load – No excitation.

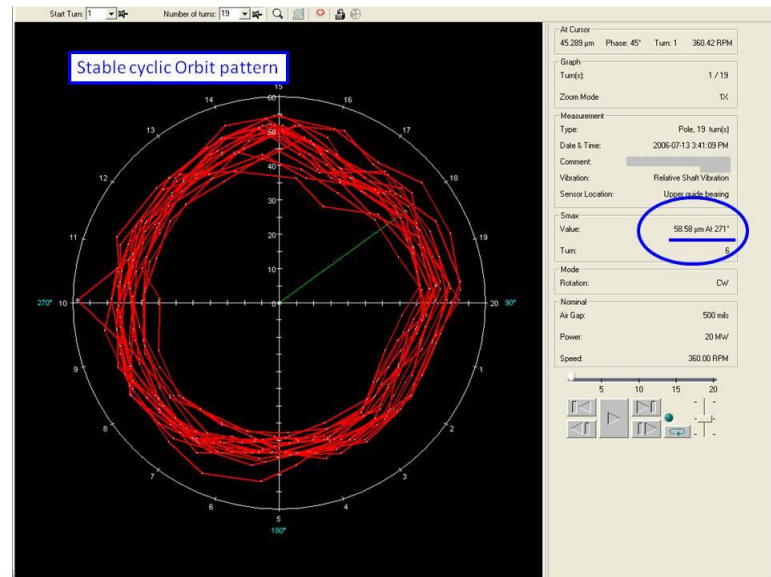
The following Orbit graph (*Figure 3*) shows quite clearly that under this operating condition, the Unit was quite stable.

Figure 3. Orbit pattern at Upper guide bearing at Speed No Load – No excitation.

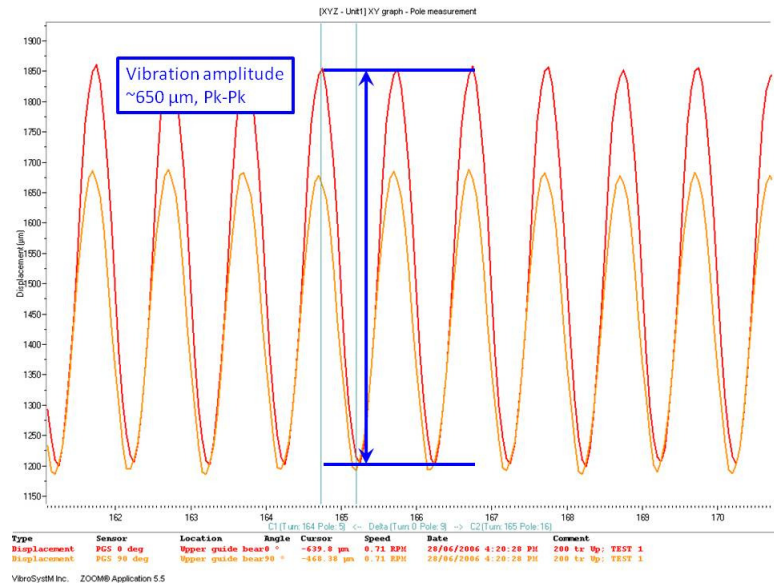
However, when the Unit was subjected to electromagnetic forces, the behaviour changed drastically. We can see in *Figure 4* of the following page that the amplitudes of vibration increase suddenly from ~100 µm, Pk-Pk up to values near 650 µm, Pk-Pk. Evidently, these values are well beyond accepted tolerance levels. Normally, the peak-peak vibration levels

should never exceed 300 μm , Pk-Pk. The vibration levels remained constant under all operating conditions including full load – hot conditions.

Figure 4. Upper guide bearing vibration at Speed No Load – with excitation.

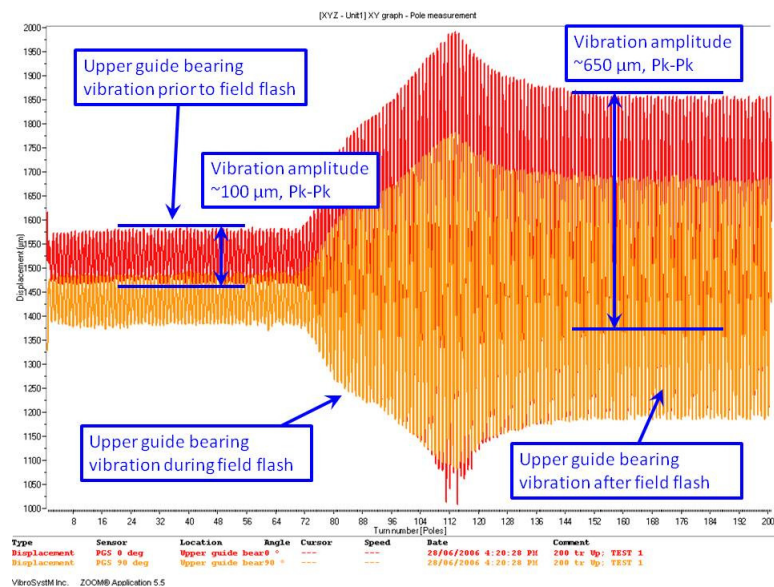
Figure 5 below clearly shows what happens to the upper guide bearing shaft displacement when the Unit is subjected to the presence of electromagnetic forces.

Figure 5. Upper guide bearing vibration before, during and after field flash.

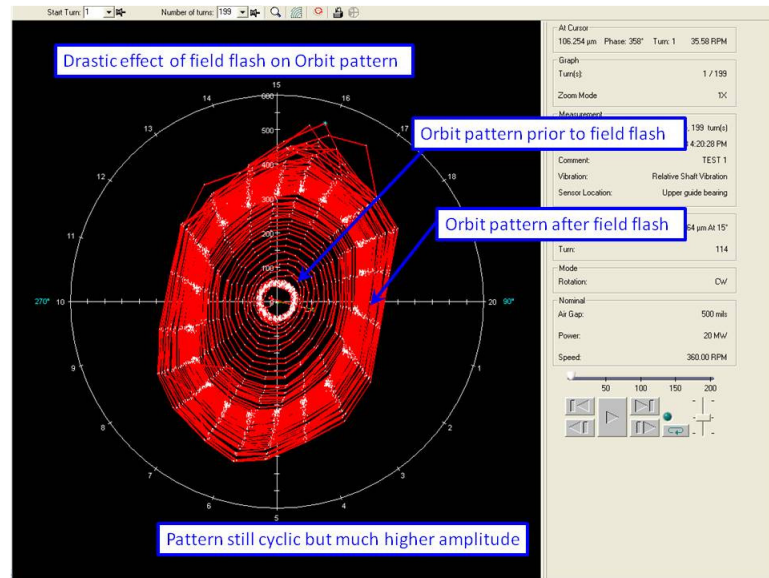
Figure 6 shows a classic representation of the effects on the Unit. The Orbit graph clearly displays the increase in the Orbit pattern at the upper guide bearing as the field is applied. The orbit pattern at the lower guide bearing showed a similar pattern. Although the increase in relative shaft displacement is spectacular, it is still quite stable in that the apparent heavy spot remains at or near pole 16 at all times (275° phase offset). The ZOOM[®] system software has a unique Orbit feature which allows for a quick and easy identification of the apparent heavy spot

Figure 6. Orbit pattern at Upper guide bearing before and after field flash.

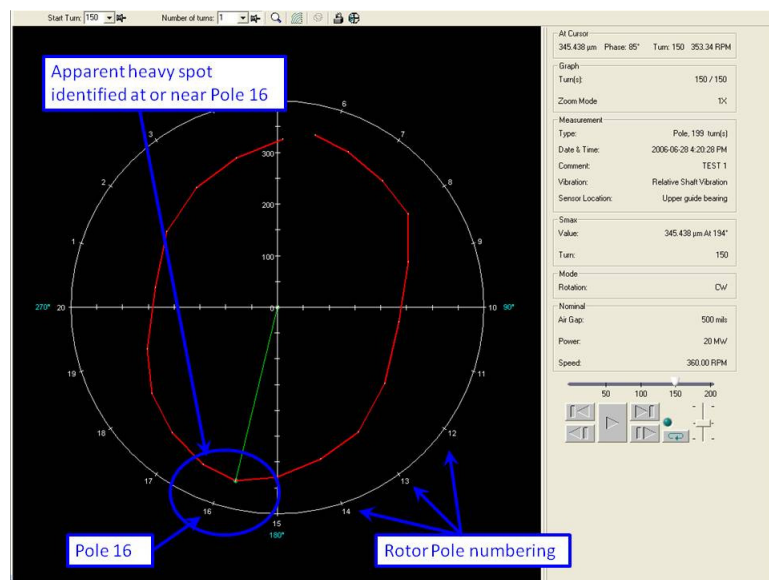
Figure 7. Orbit pattern at Upper guide bearing after field flash.

allows for a quick identification of the apparent heavy spot and thus renders balancing much easier. The following graph (*Figure 7*) shows how the orbit feature clearly identifies the apparent heavy spot location, which in this case is at or near pole 16. The numbers displayed all around the circumference of the Orbit represent the position of the rotor poles when the Orbit center point was recorded.

Many engineers faced with this kind of vibration situation would begin balancing procedures in order to reduce the vibration amplitude levels down to accepted tolerance levels. Based on the information provided by the Orbit feature, engineers would calculate the true heavy spot, based on OEM published data. The correction is usually anywhere from 5° to 25°, depending on many factors such as rotor mass, inertia properties ...etc. With this correction, a compensating weight is added to the rotor in an attempt to reduce the vibration levels. The amount of weight and its location radially depends on the properties of the rotor itself and is particular to each Unit. Usually, a test weight is used, and the results once the Unit is brought back to speed no load – excited condition are compared with the original results to evaluate the success or failure of the attempt. If the unbalance is stable, in that the apparent heavy spot does not change from one rotation to another, usually the balancing is performed in two (2) or three (3) attempts, depending on the final objectives set forth prior to the balancing procedure.

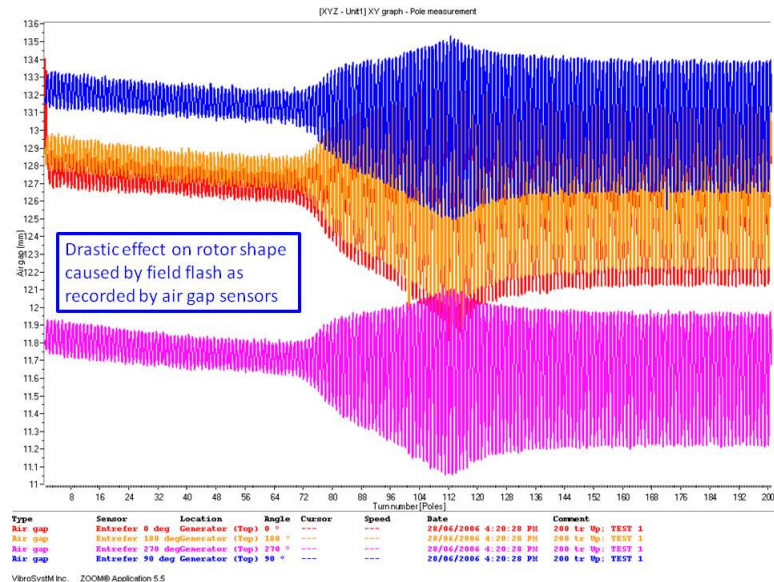
However, as mentioned in the Introduction segment of this paper, along with the vibration monitoring system, this customer also installed an air gap monitoring system. Data from these sensors were then analysed in support to the vibration. *Figure 8* on the following page shows the effects of the electromagnet forces on the rotor. A clear increase in rotor shape can be easily observed. All four (4) air gap sensors report the same pattern. However, the rotor shape did not

Figure 8. Air gap behavior before and after field flash

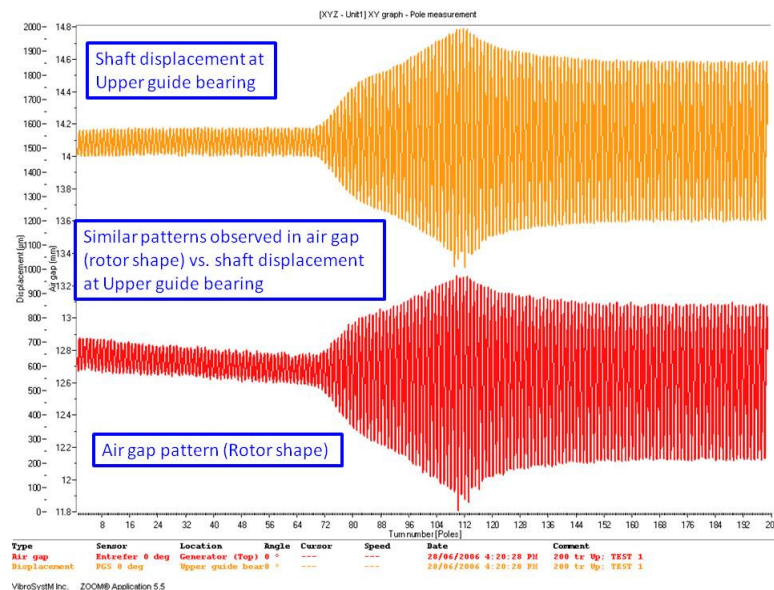
increase significantly, as we can see in *Figure 10*. In fact, the increased runout near the rotor, at the upper and lower guide bearings, confirmed by results from these shaft displacement probes are causing significant distortions in the air gap readings. The air gap sensors are mostly recording rotor movement variations instead of pure rotor shape changes. The ZOOM[®] software has a feature which allows for this excessive runout, as recorded by two (2) displacement probes, to be removed from the air gap results, in fact leaving the user with a clear picture of the actual rotor shape changes. *Figure 9* below compares the air gap variations (rotor shape and position changes) with the upper guide bearing shaft displacement without the runout filter activated. We can see that the patterns are identical.

Figure 9. Rotor shape without runout filter applied.

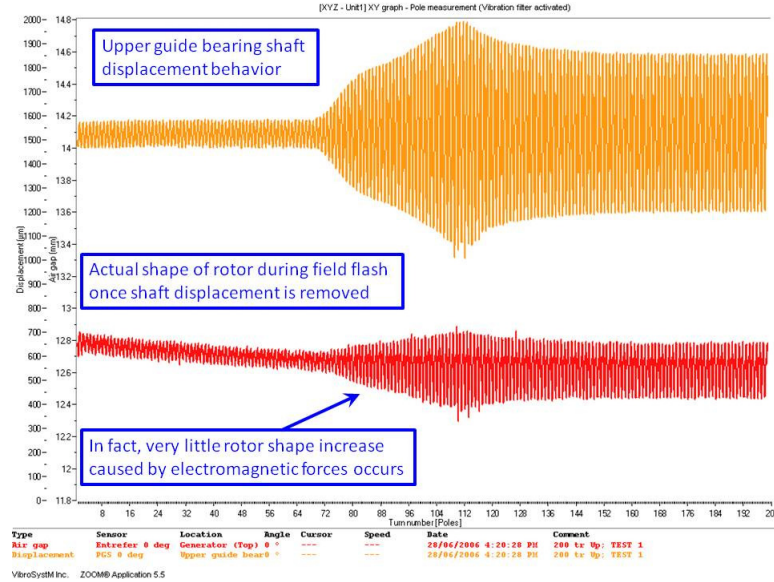
Figure 10 below compares the actual air gap variations (rotor shape and position changes) with the upper guide bearing shaft displacement but with the runout filter activated, leaving the actual results instead of those displayed in *Figure 8*. The increase in rotor shape is common as the rotor rim, dove tails, rim to spider attachments are subjected to the electromagnetic forces therefore; some shape irregularity is usually observed. This situation is normal, so long as the overall rotor circularity (its overall shape performance) and concentricity (its overall position) remains within accepted tolerance levels. *Figure 11* of the following page is a representation of the rotor spinning around inside the stator, where we can see that the rotor bump creates an uneven

Figure 10. Actual rotor shape with runout filter applied.

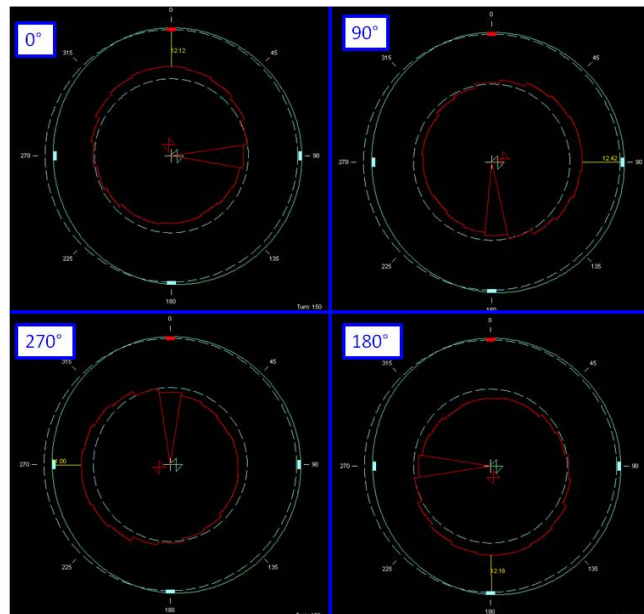
magnetic field at various locations as the Unit rotates. This varying magnetic field creates the excessive vibration values and phase, observed by the relative shaft displacement probes.

Figure 11. Bump on rotor as it rotates inside the stator.

Arguments could be made that the solution would be to balance the rotor however; in this case, balancing was not the issue at all. Balancing the rotor would only hide the fact that the rotor shape did not meet acceptance criteria. Clearly the bump located in the general area of pole 16 generated an uneven magnetic field at field flash, creating a magnetic instability thus increasing the upper and lower guide bearing vibration to unacceptable levels. Balancing the Unit would not correct the bump therefore; the uneven magnetic field would still remain, causing short term damage to both the rotor and stator. Rotor wear and tear would occur based on the fact that the area where the bump is located would be subjected to higher than expected electromagnetic forces, creating excessive stress and hot spots on the components of the poles, rim and spider. As for the stator, varying magnetic fields, created by the oscillation of the rotor, would induce stator core vibration at once per revolution cycle, and would eventually cause stator structure fatigue, deterioration of the stator bar insulation, induce stator bar vibration and eventually, stator bar insulation failure.
