AIR GAP MONITORING KEY ELEMENT TO AVOID UNNECESSARY AND COSTLY REPAIRS

André Tétreault

Director
Tests & Diagnostics Division
VibroSystM Inc.
2727 Jacques-Cartier boul. east
Longueuil, Qc
Canada (J4N1L7)

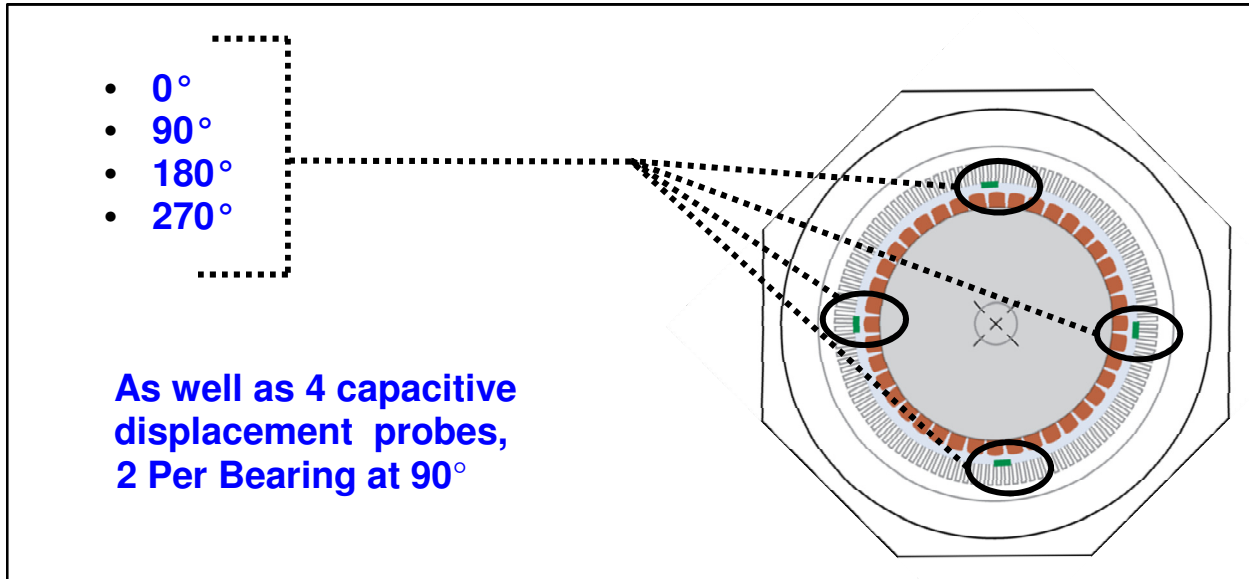
Figure 1 Location of air gap sensors on stator core

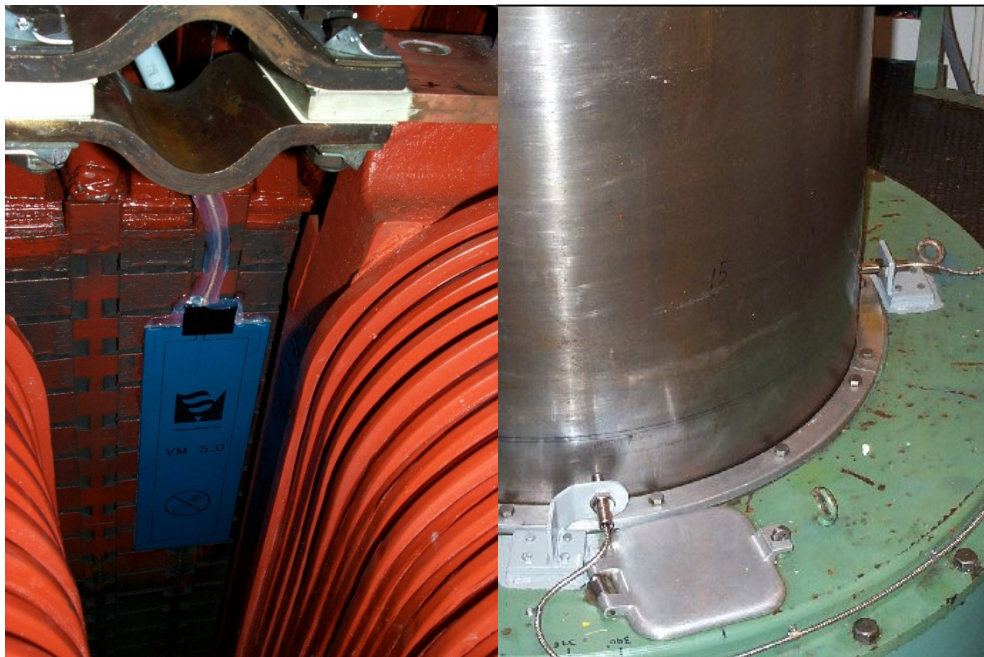
Figure 2 Air gap sensors installed on stator core and radial shaft displacement probes.

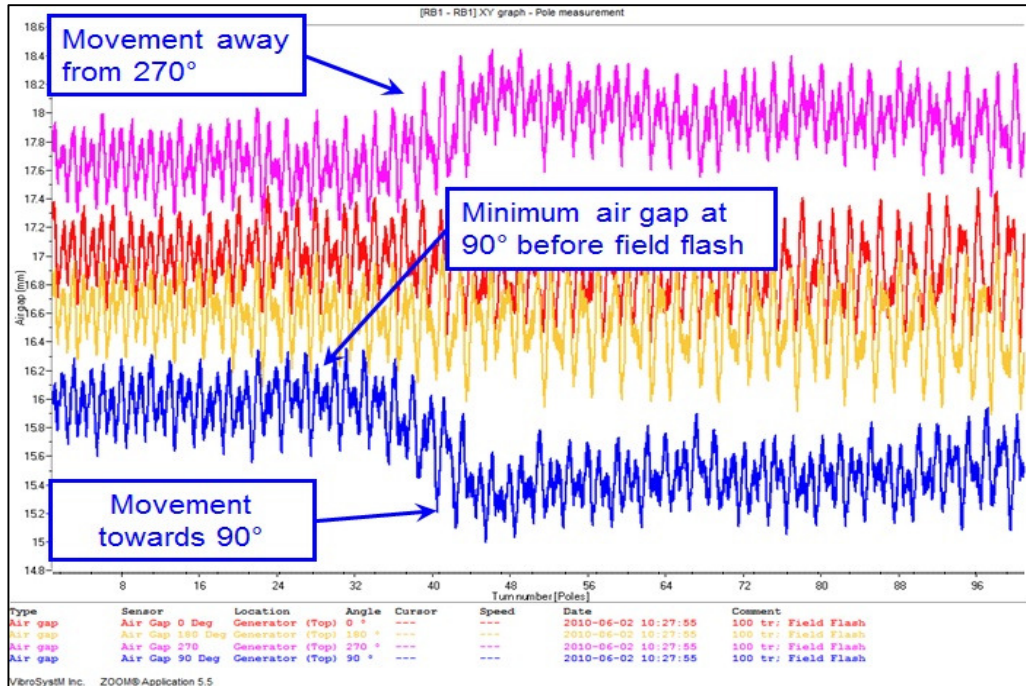
Figure 3 of the following page shows the rotor behaviour as the magnetic field is introduced into the air gap. We can clearly see that the rotor is pulled in the direction of 90° (blue trace), while moving away from 270° (purple trace). The moment the magnetic field appears, the rotor and stator are subjected to very high electromagnetic forces. The position of the rotor, in regards to the stator, is crucial at this moment if the Unit is to maintain an electromagnetic stability. In this case, the air gap prior to the field flash is smaller at 90° (~ 16,0 mm) than at 270° (~ 17,5 mm) therefore; the forces in the area near 90° are much greater than those present near 270°. The end result is that the rotor is instantaneously pulled towards the smallest air gap, found at 90°. In this case, the rotor moved from its mechanical centre to its magnetic centre by a distance of ~ 500 µm. At the same time, the upper guide bearing shaft displacement probes recorded a movement of ~ 370 µm (See Figure 4). The variation between the rotor movement and the shaft movement is due to additional factors; such as stator core movement towards the air gap as well as rotor expansion.

Figure 3 – Magnetic center vs. mechanical center

- 1- Unless visible signs of rotor wear and tear are present, structural work on the rotor is not warranted in this case. If during visual inspection of the rotor and its components, signs of red powder, stress cracks are found, these would be clear signs of compromised structural integrity.
- 2- If re-centering of the rotor is not possible during the next outage, then repositioning of the stator should be considered to align the magnetic and mechanical centres of the rotor/stator.
- 3- The upper guide bearing should be verified in order to determine the source of the sub-synchronous frequencies, as well as the reverse orbits found at 25 MW. The possible causes are misalignment of shaft, problems with oil film distribution and bearing integrity issues.

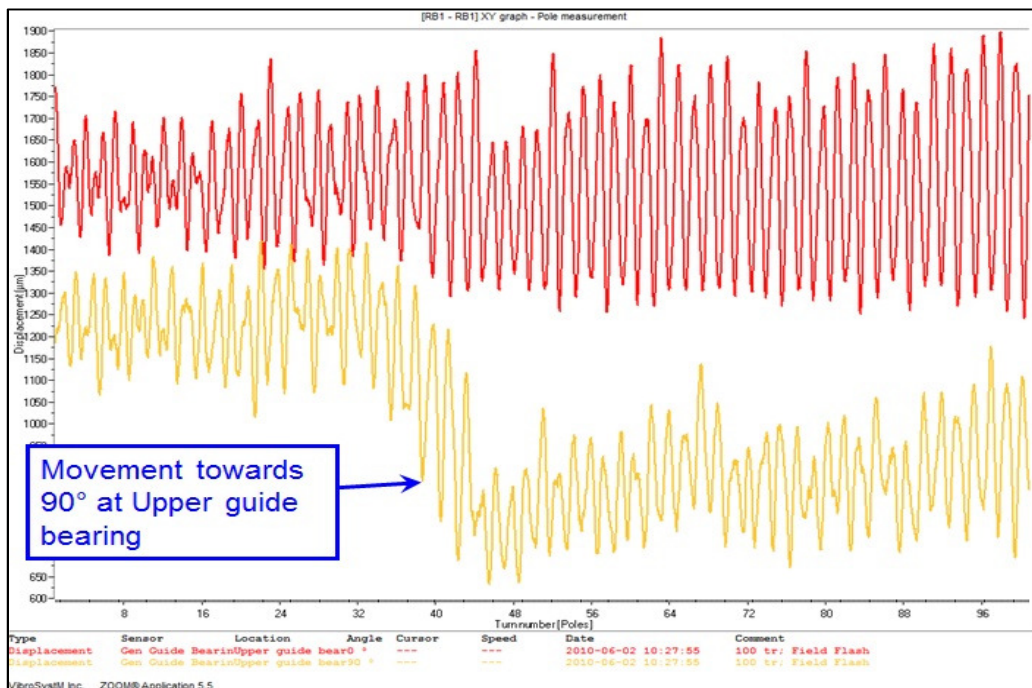
Figure 4 – Magnetic center vs. mechanical center at upper guide bearing

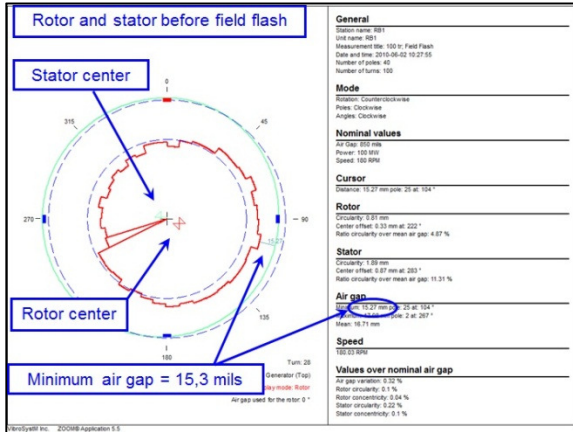
Figures 5 and 6 below represent polar views of the same movement towards 90° upon field flash. An air gap decrease of ~ 500 μm was observed.

Figure 5 – Rotor and stator before field flash

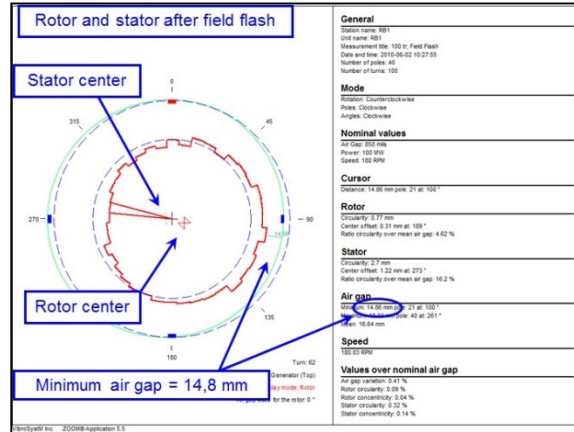
Figure 6 – Rotor and stator after field flash

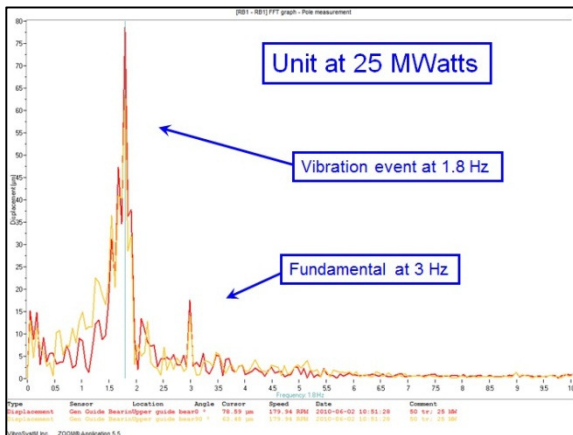
Figures 7 and 8 below show the vibratory behaviour of the shaft while the Unit was operating at 25 MW. A sub-synchronous frequency can clearly be observed at the upper guide bearing (1.8 Hz). The fundamental frequency for this Unit is 3 Hz (180 RPM). The Orbit graph indicates clear evidence of skating whereas the Unit requires more than one (1) rotation to complete its Orbit. This skating phenomenon is represented in the FFT graph as a sub-synchronous frequency. In addition, reverse orbits were recorded when the Unit was operating at this load. We can see in the Orbit graph that although this Unit's rotation direction is counter-clockwise, the Orbits path is clockwise (the first rotation is in white while the second rotation is presented in red).

Figure 7 – Sub-Synchronous frequency at 25 MW

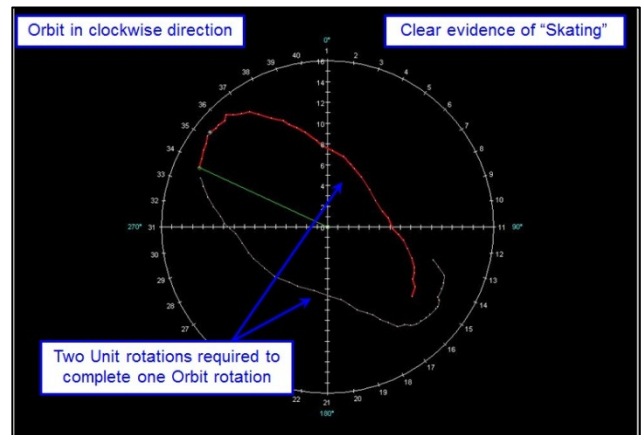
Figure 8 – Evidence of skating at upper guide bearing

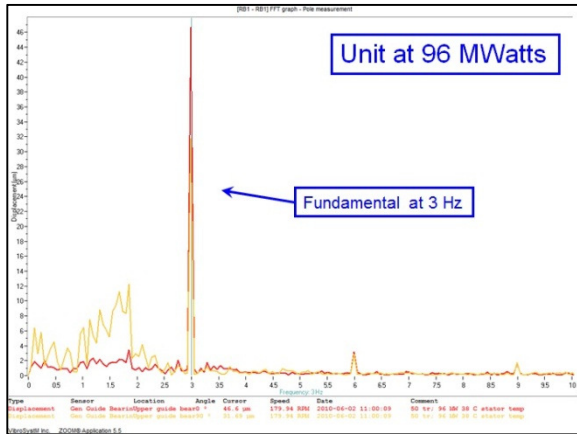
Figures 9 and 10 of the following page show the vibratory behaviour of the shaft while the Unit was operating at 96 MW. The aforementioned sub-synchronous frequency values have greatly decreased. The fundamental frequency values have increased but are still at acceptable levels (~ 130 μm, pk-pk). The Orbit graph indicates that the Orbit path was now stable in that one rotation per turn was present and no reverse orbits were observed.

Figure 9 –Fundamental at 96 MW

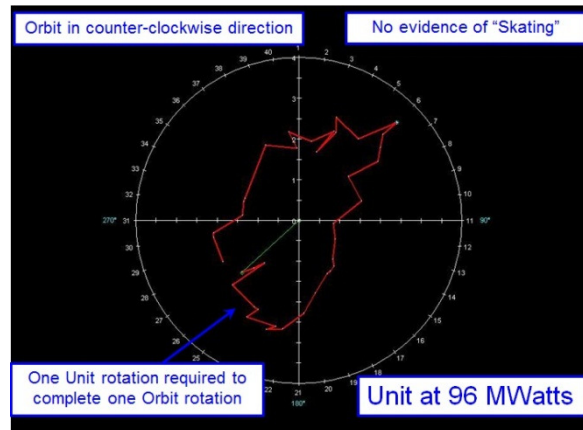
Figure 10 – Skating absent at 96 MW
