End-winding vibration monitoring: Pivotal in preventing major damage on a large turbo-generator

André Tétreault

Zhou, Zhengping

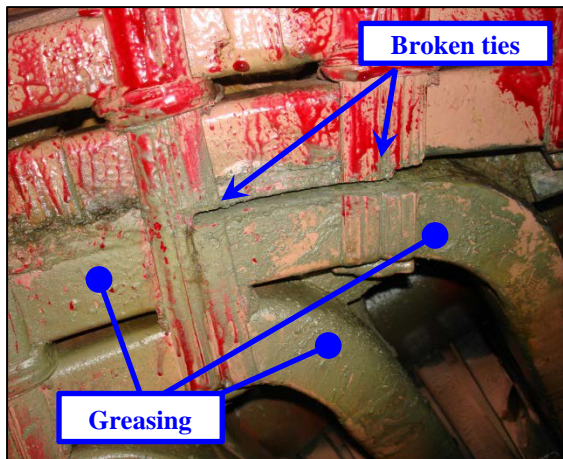
Fig. 1. Greasing and broken ties.

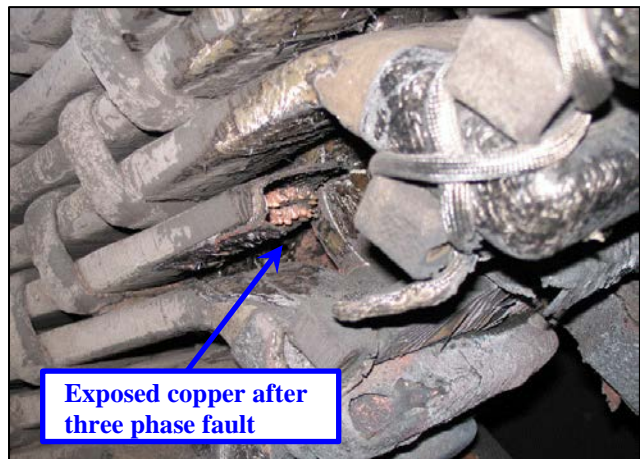
Fig. 2. Three phase fault.

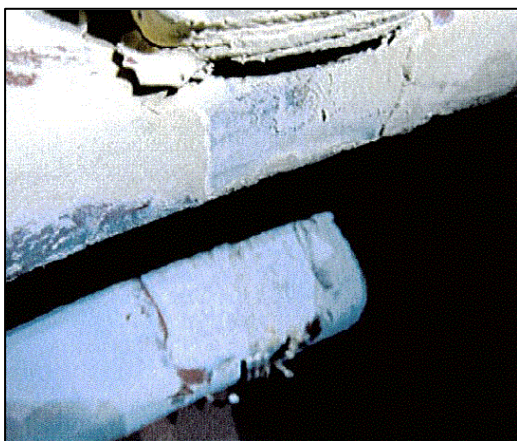
In June of 2010, Unit 2 of the Tianwan nuclear power plant was inspected during an outage. This 1060 MW 2 pole Unit had experienced end-winding integrity issues in 2009. At that time, winding 1C1 was found to have loose blocking, causing the natural frequency to decrease close to 100 Hz, inducing excessive vibration of the winding. The repairs included replacement of connector between 1C1 and insulation box. During this new outage, many issues were found inside the Unit. Firstly, ties were found to have broken; to such an extent that spacers between winding 1C1 and 2C2 had dropped off, leaving end-windings at that location without structural support (*See Figure 3*).

Fig. 3. Location of missing spacer.

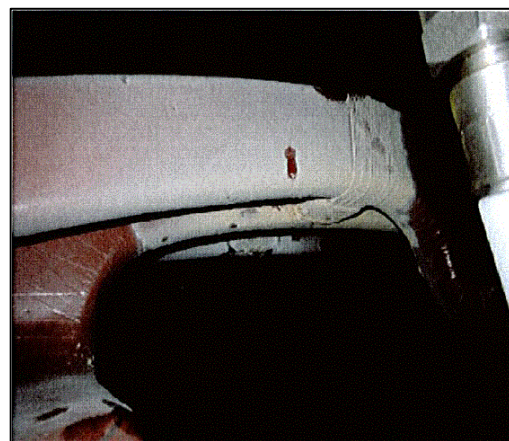
Fig. 4. Presence of dusting between 11 and 1 o'clock.

Secondly, signs of end-winding abrasion were found (identified as white powder), specifically in the area between 11 o'clock and 1 o'clock (See Figure 4). Thirdly, a broken water pipe connector was found at the exciter end of the Unit (See Figures 5 and 6).

The abrasion at 11 o'clock was also attributed to thermal expansion and contraction between the phase leads and the stator windings, due to the electro-magnetic forces, whereas excessive vibrations were induced. It was determined that the rigidity of the whole end-winding structure was inadequate and the problem was attributed to poor workmanship and manufacturing issues.

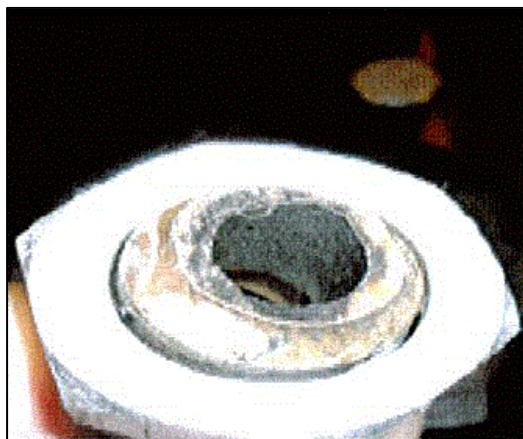
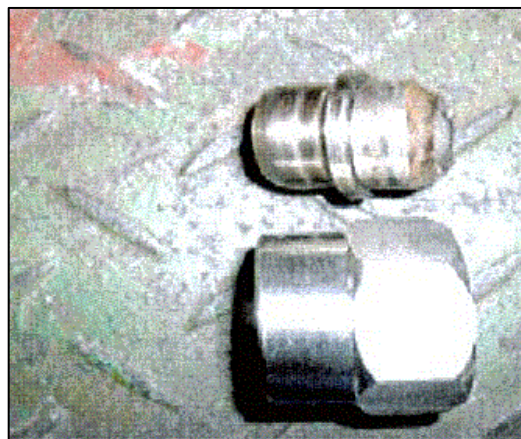
Fig. 5. Broken water pipe connector.

Fig. 6. Other view of broken water pipe connector.

The cause of water pipe connector rupture was also attributed to the weakening of the rigidity of the whole end-winding structure, which over time, induced vibration and therefore; the connector was subjected excessive stress hence, the rupture due to fatigue. A scratch was also found on the connector surface, which might also have been the cause.

- The flexible connectors were replaced. The use of impregnated Polyester Fiberglass ties (wet ties) to bind the end of the connectors, in order to divert the stress on the connectors and prevent them from breaking and causing ground faults.
- The cracked phase lead was replaced.
- The defective water pipes were replaced.
- The flexible connectors in the insulator case (C4, C6 and 1C3) were replaced.
- The areas near 11 and 1 o'clock were modified by using impregnated Polyester Fiberglass ties to tie up the support blocking and filler material. Epoxy putty was reapplied on the phase leads at 11 and 1 o'clock. Additional ties were installed to tighten up the phase leads.

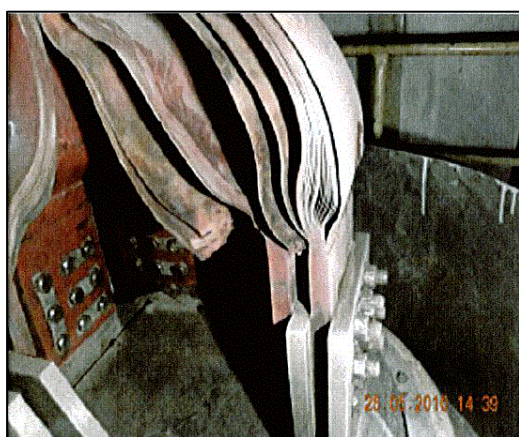
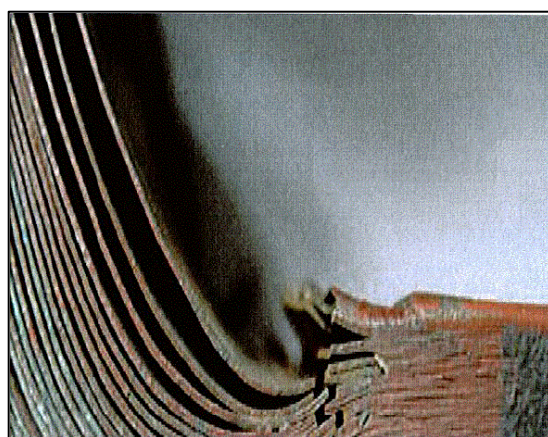
Fourthly, phase output connectors were found to have broken strands in 5 different locations, the worst case had 5 broken strands on Phase A. (See Figures 7 and 8).

Fig. 7. Broken phase output connectors.

Fig. 8. Broken phase output connectors.

The cause of the phase output flexible connector rupture was attributed to corrosion and excessive vibration. The cause of the flexible connector rupture inside the output insulator case was attributed to vibration of the phase lead.

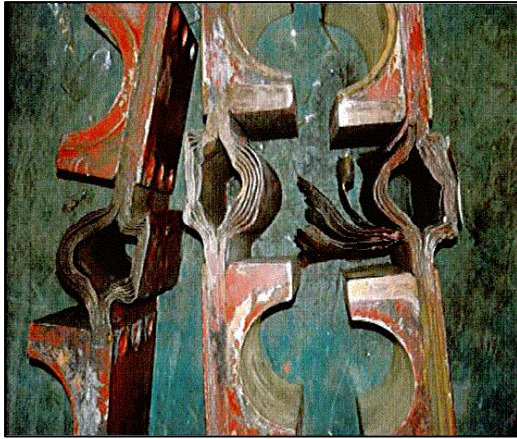
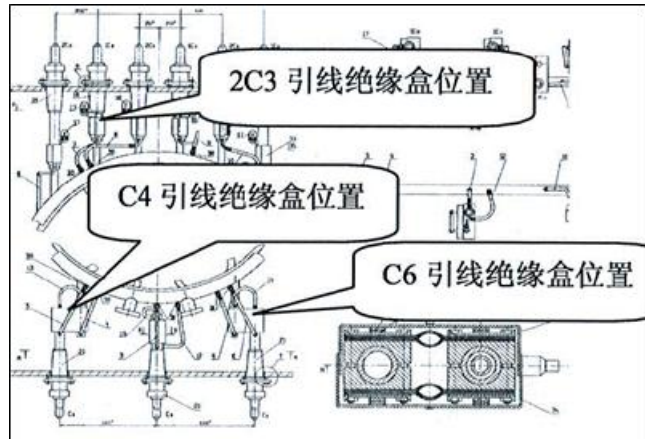
Fig. 9. Broken phase output connectors.

Fig. 10. . Broken phase output connectors.

Fifthly, the phase output insulator case was dismantled and phase leads 1C3, C4 and C6 were found to have a total of 4 flexible connectors broken (See Figures 9 and 10).

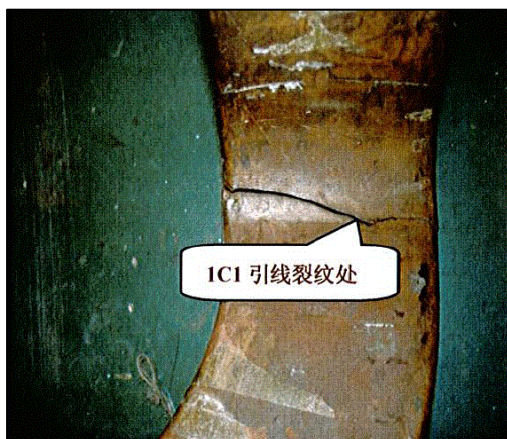
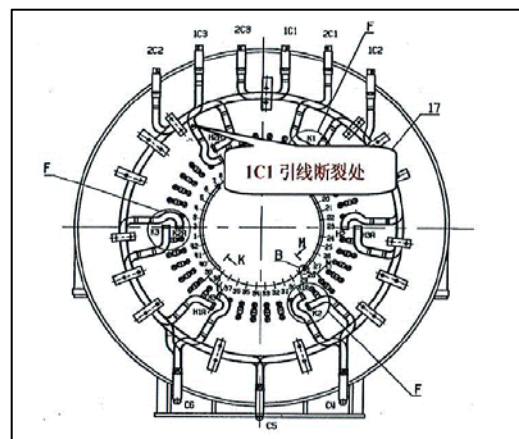
Finally, a serious arc-shaped crack was found on winding 1C1, suspected to have been caused by excessive end-winding vibration (See Figure 11). This crack was found at the exciter/collector end, in the area of 11 o'clock (See Figure 12). A water pressure test was performed and a water leak was confirmed.

Fig. 11. Significant crack found on end-winding.

Fig. 12. Location of cracked end-winding on collector end.

It was determined at the time that the crack was caused by a differential between thermal expansion and contraction between the phase leads and the stator windings themselves. This winding had broken in August of 2009 and the repairs included the addition of 3 Kg of weight to the phase lead and end-winding. No additional actions were taken on the phase lead.

In addition, it was believed that loose support blockings became loose and caused the resonant frequency to decrease too close to the 100 Hz electro-magnetic frequency, causing excessive vibration of the phase lead. The loosening of the support blockings was attributed to binding ties which were too thin, a lack of filler material between support blockings and the phase leads.

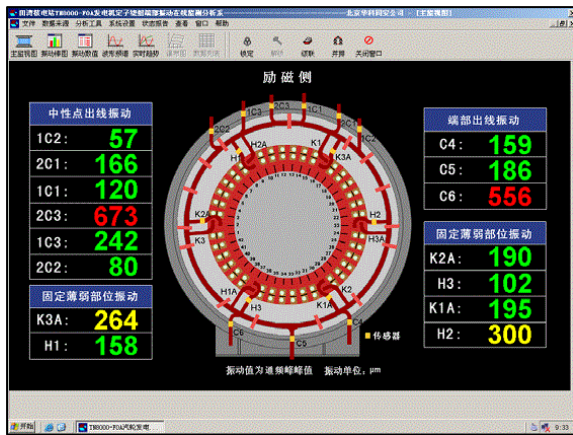
In June of 2011, the results recorded on phase lead position 2C3 showed that alarming peak-peak vibration levels were present. Values of varying from $\sim 600\mu\text{m}$ to $\sim 700\mu\text{m}$, peak-peak, were regularly observed. Figure 17 displays the actual vibration levels recorded on September 16th, 2011. We can see that the results from C6 were also alarmingly high at $\sim 500\mu\text{m}$ to $\sim 600\mu\text{m}$, peak-peak. Although no existing tolerances have been published by international standards organization in regards to end-winding vibration levels; our experience has shown, and most experts in the field of end-winding vibration agree, that vibration levels should be less than $300\mu\text{m}$, peak-peak at 100/120 Hz at all times. In fact, you should be able to obtain levels below $50\mu\text{m}$, peak-peak at 100/120 Hz. Any level beyond $300\mu\text{m}$, peak-peak would be considered quite high, and any results beyond $500\mu\text{m}$, peak-peak, again at 100/120 Hz, should be considered critical. These tolerances are considered conservative and many experts believe that these tolerance levels should be lower. It is important to bear in mind that the results obtained may not be the highest values existing on the Unit as the location where the fiber-optic sensor is installed may not be the location where the vibration values are the highest. Figure 18 shows the fiber-optic sensor on the 2C3 end-winding.

Fig. 17. End-winding vibration results on 2011-09-16.

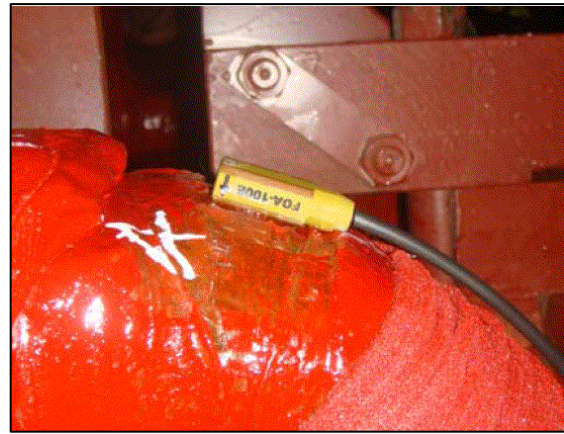
Fig. 18. Location of sensor at winding 2C3.

On October 22nd, 2011, while Unit 2 was operating, a hydrogen leak was detected, which eventually forced a new outage. The Unit was shut down on November 2nd, 2011. A visual inspection was performed and a new crack was discovered at phase lead 2C3, very near to where a fiber-optic accelerometer had been installed (See Figure 18). This sensor was the one which was reporting the highest vibration values (See Figure 17). It is quite plausible that this crack would have developed into a major issue on this Unit, in the short to mid-term. It is important to remember that epoxy-mica insulation material has excellent electrical insulation properties however; its mechanical properties are somewhat of a problem. The rigidity of the epoxy-mica insulation material makes it very susceptible to kinetic sources of energy therefore; resonances must be managed and high vibration amplitudes must absolutely be kept to a minimum. Excessive levels of vibration, as was observed on this Unit, cannot be tolerated for any significant periods. If such vibration levels are not dealt with in the short term, the integrity of the insulation material, the support structure, and finally the copper strands inside the windings, depending on the severity of the vibration levels, its frequency range and its location, can deteriorate rapidly and cause a major end-winding failure. The 2C3 fiber-optic sensor was removed in order to perform repairs on the phase lead. After repairs were performed, the fiber-optic sensor was reinstalled and the Unit was put back in operation. Subsequent readings showed that the repairs were successful in significantly reducing the vibration levels at that location (2C3). The new vibration levels were in the range of 250 μm , pk-pk. Although significantly reduced, the vibration levels are still somewhat high but now acceptable. The levels will be closely monitored in the future, whereas any increase beyond the accepted tolerance levels will be detected and dealt with accordingly.
