Concrete Expansion – R.H. Saunders GS Innovative Structural Rehabilitation & Mitigation Effectiveness

*Keith T. Eastman, Ontario Power Generation, Cornwall, ON, Canada
John Deans, Kinectrics, Toronto, ON, Canada, and
Edward S. Li, Ontario Power Generation, Cornwall, ON, Canada*

ABSTRACT

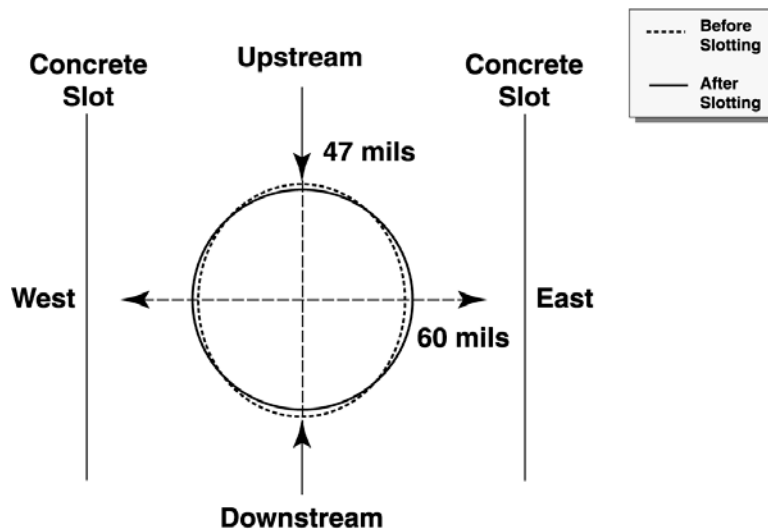
Figure 3 - Diametrical change in runner clearance

The immediate response of concrete slotting was beneficial. Re-establishment of the expansion/contraction joints resulted in reduced longitudinal compressive stresses in the concrete and partial rounding of the throat ring liners. The average diametrical runner clearance decreased 47 mils in the transverse direction and increased 60 mils longitudinally as predicted by the analytical model. See Figure 3.

Localized concrete slotting of the expansion/contraction joints was implemented to mitigate the effects of AAR. Slots 9/16 in. wide were cut through the original expansion/contraction joints in the vicinity of the generator/turbine sets, using diamond wire cutting technology. The slots re-established and widened the joints thus relieving the longitudinal compressive stresses and partially rounding the throat ring liners.

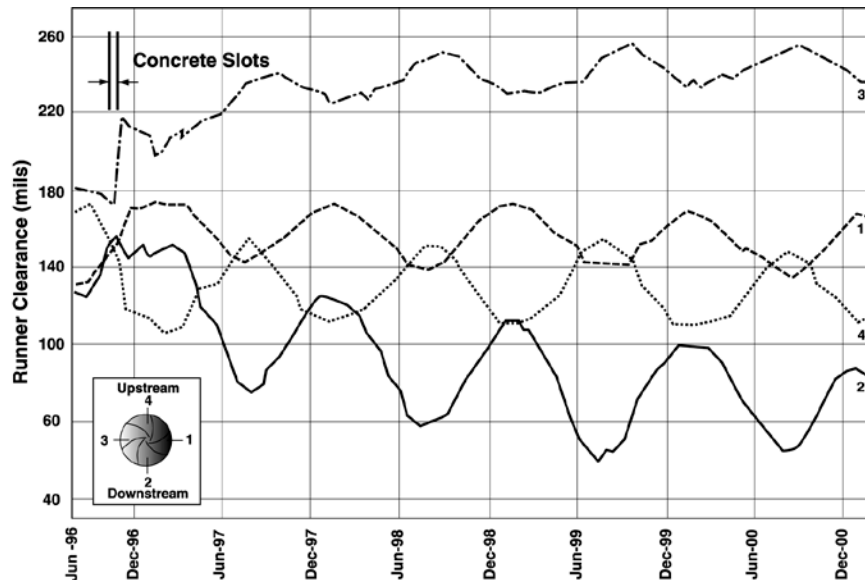
Subsequent to the slotting program, however, the runner clearances have decreased, in the vicinity of the downstream proximity probes, at a rate of 10 mils/year. See Figure 4. This is due to the continued relief of longitudinal compressive stresses. It is expected that this trend will reverse once the compressive stresses due to continued concrete expansion overcome the temporary relief provided by the contraction joint slots.

Figure 4 – Runner clearance – 10 mils/year decrease (downstream)

Since concrete expansion continues at R.H. Saunders GS, the slots were designed to accommodate future concrete expansion without the need to re-slot the joints for at least ten years.

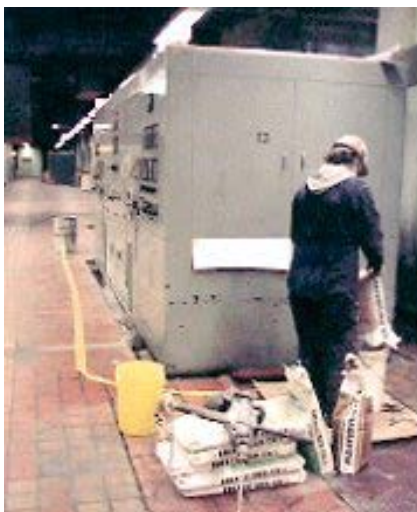
The governor cabinet concrete supports had been severely damaged due to concrete movement. Lateral movement (up to $\frac{3}{4}$ in.) caused severe cracking and spalling of the concrete. Repairs entailed the removal and replacement of the damaged concrete, addition of new steel column supports with sliding Teflon pads to accommodate future movement and extensive structural grouting of numerous fractures in the concrete. See Figures 7 and 8. Post tensioning of the existing reinforced concrete columns was undertaken. These solutions were implemented based on ease of construction, space restrictions and operating requirements

Figure 7 - Preparing to grout around a governor cabinet

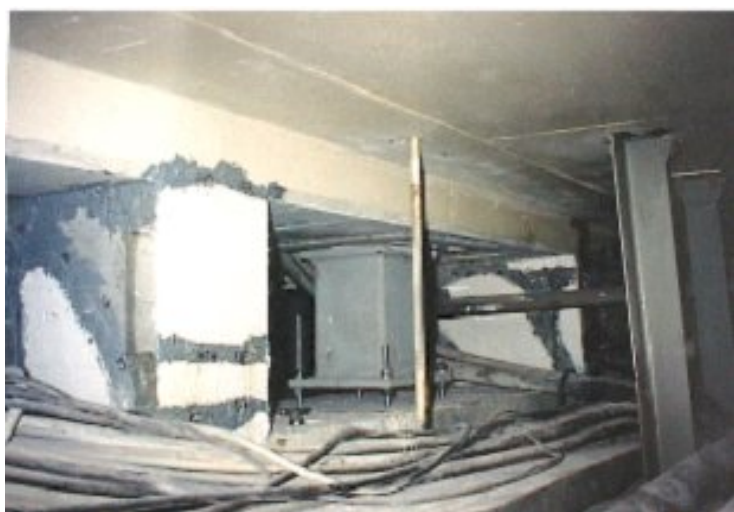
Figure 8 - Structural grouting of columns and new steel column support

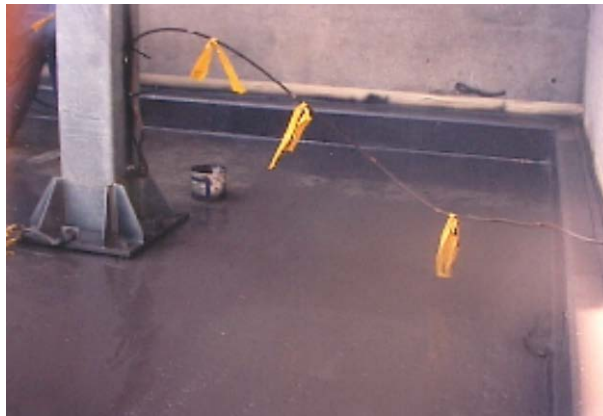
Previous inspections of the bays indicated that the liners were no longer completely water tight due to local cracking and deterioration of the concrete and joint sealant.

Figure 13 - Transformer bay oil containment liner

The repair consisted of local patching of the concrete, replacement of the existing deteriorated joint sealant, surface preparation of the concrete by sandblasting methods and application of a two-component polysulphide base coating. This material was selected as a result of its chemical and UV resistance, and flame retardant and crack bridging characteristics. It provides oil resistance and a leak-proof barrier to transformer oil in the event of a transformer oil spill. The coating also provides a protective layer over the concrete reducing the rate of deterioration and extends the life of the concrete structure. See Figure 13.
