# Rotor shape vs. rotor field pole shorted turns

Impact on rotor induced vibrations on hydrogenerators

André Tétreault Tests & Diagnostics Division VibroSystM Inc. Longueuil, Qc, Canada

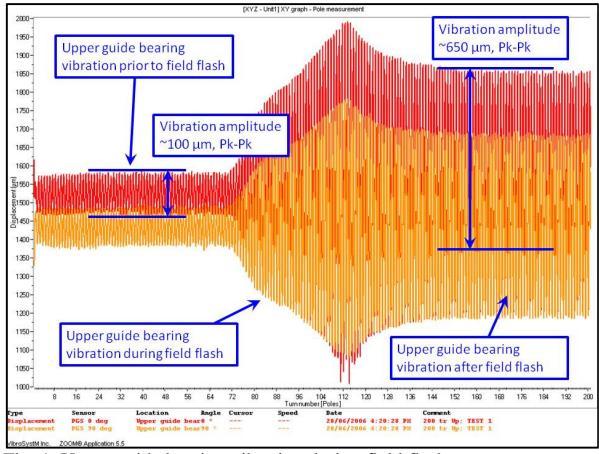
Case in point, example 1 is typical of an irregularly shaped rotor causing elevated vibration levels when the magnetic forces are introduced in the air gap. Fig. 1 below represents the raw vibration (X & Y, 90° apart) recorded at the upper guide bearing of this vertical hydro-generator before and after the excitation event. We can clearly see the dramatic increase in vibration recorded by both probes. Usually, when the magnetic forces appear in the air gap, the vibration levels decrease as the forces act as a stabilizing force.

Fig. 1. Upper guide bearing vibration during field flash event.

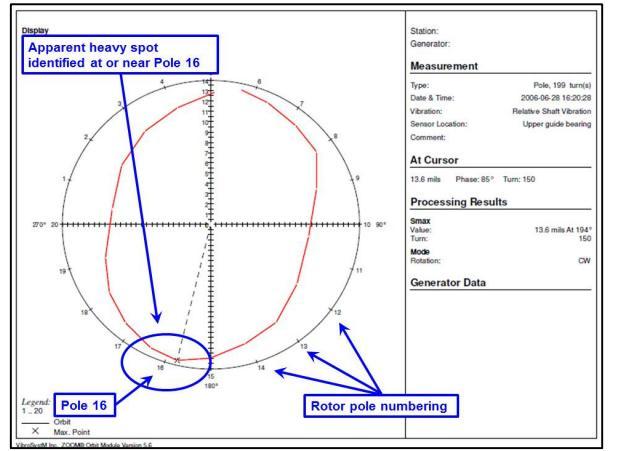
Fig. 2 shows the Orbit graph of the same event and the apparent heavy spot is clearly identified as being at or near pole 16. It is quite common to see personnel begin balancing procedures when facing such a situation.

Fig. 2. Orbit pattern at upper guide bearing after field flash event.

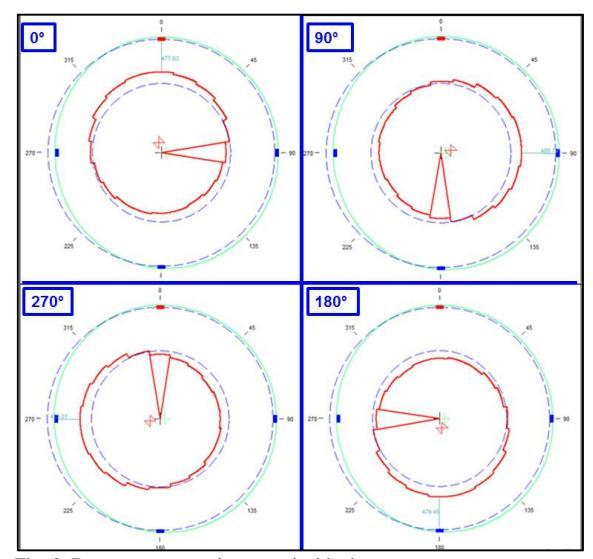
However, close scrutiny of the air gap data indicated that the increased vibration was caused by a bump on the rotor, located in the general area of pole 16 (as shown in Fig. 3), causing a cyclic oscillation whereas the protruding portion of the rotor was being dragged around the stator at each rotation. Therefore; balancing the rotor would not resolve the issue and in fact, would surely deteriorate the situation. The correct intervention in this case would be to re-shrink the rotor rim to significantly improve the rotor shape and stiffness.

Fig. 3. Bump on rotor as it rotates inside the stator.

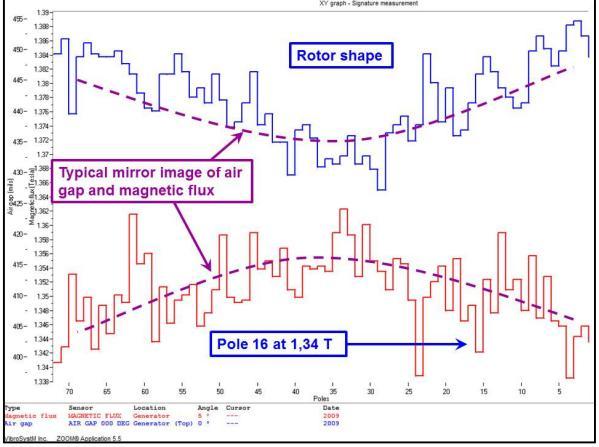
The second example shows how little effect small numbers of shorted turns have, not only on the overall intensity of the magnetic flux, but also on the vibration levels at or near the rotor. Fig. 4 is a representation of an air gap signal vs. a magnetic flux intensity signal at the same location. As expected, the air gap and magnetic flux signals are inversely proportional in that the smaller the air gap, the higher the intensity of the magnetic field, with a small variation caused by each poles capacity to produce the expected magnetic field intensity. Fig. 4 in this case indicates pole 16, which was reported to have two shorted turns out of a total of 23, following a voltage drop test. This represents 8.7% of the total number of turns however; we can see that the corresponding flux is not significantly affected by this problem. Data recorded three years before the shorted turns were detected, showed no significant variation in flux density and in fact, the actual vibration levels were less than 50 µm, pk-pk with the shorted turns.

Fig. 4. Air gap vs. magnetic flux.

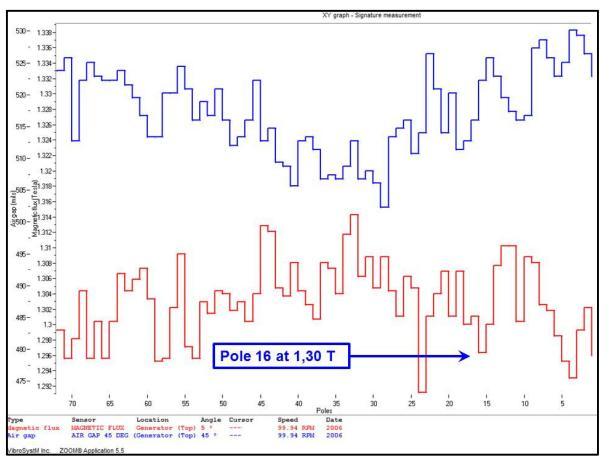
Therefore; it is reasonable to say that the presence of shorted turns did not have any impact on the vibration levels. Fig. 5 below contains the results for the same generator but 3 years prior to the detection of the shorted turns on pole 16. We can see that no magnetic flux intensity variation is noticeable.

Fig. 5. Air gap vs. magnetic flux 3 years prior to detected shorted turns.

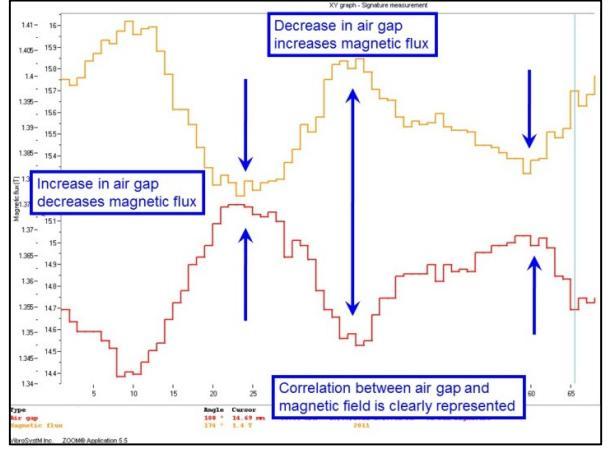
Fig. 6 represents the clear relationship between the air gap found in one location of the generator and the magnetic flux intensity. We can clearly see how an out of round rotor (significant air gap variation) produces a corresponding varying magnetic flux signal. This variation easily produces increased vibration levels that can be recorded not only on the shaft, but also on the stator bars and core. Excessive electro-magnetic force variations on the stator bars will wear down the insulation prematurely and eventually will cause insulation failure. In addition, excessive variations in the forces exerted on the stator core can easily lead to stator core and frame structural problems such as wear of insulation between core laminations due to increase of the vibration levels overall.

Fig. 6. Correlation between air gap and magnetic flux.

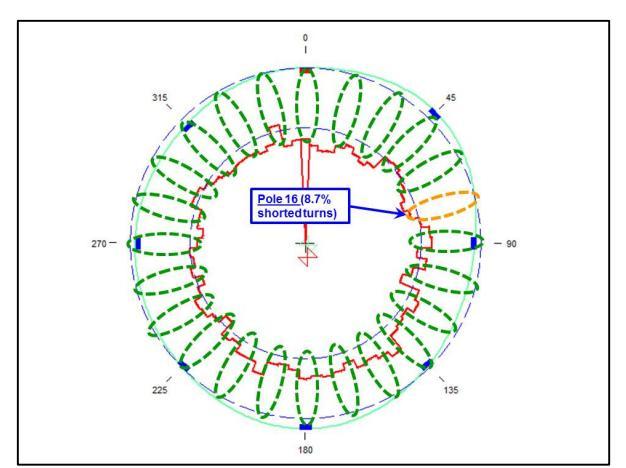
Fig. 7 represents the distribution of electro-magnetic forces in the air gap of the aforementioned generator which had one pole (Pole 16) that had the two reported shorted turns.

We can see that, even if this particular pole received less current (ampere-turns), it produced little less electro-magnetic forces than it would have if all its coils had been intact. Even some of its counterparts, spread all around the rotor, produce less electro-magnetic forces due to structural differences. The resulting sum of all the forces involved would show that the relationship between compensated forces and non-compensated forces is negligible.

Fig. 7. Distribution of magnetic forces in the air gap.
