**END-WINDING VIBRATION IN LARGE ROTATING MACHINES**  
**ANDRÉ TÉTREAU**  
**VIBROSYSTEM INC.**

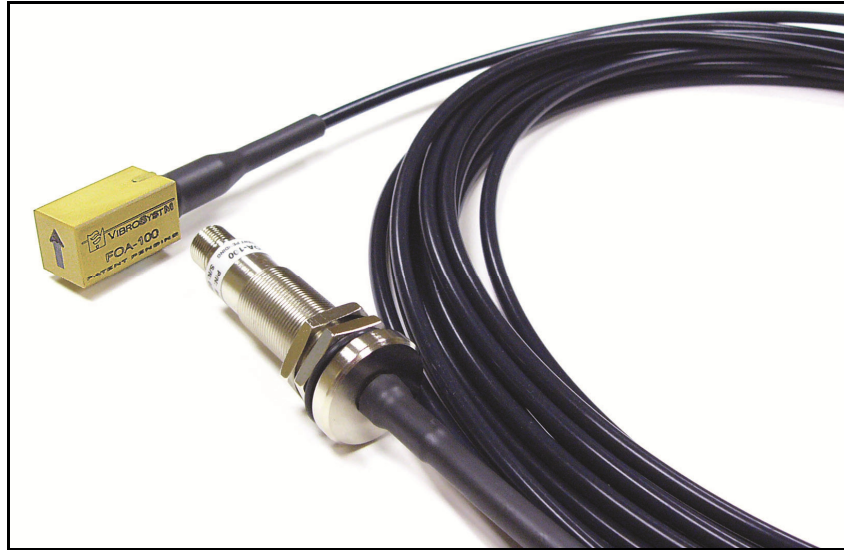
Once the location of the sensors is determined, the installation can begin. To properly fasten these sensors, two different types of epoxies are used; one for instant fastening to the end-winding surface and a second one which is used with fiberglass tape for final fastening of the sensor. Figure 2 is an example of the FOA accelerometer.

**Fiber Optic Accelerometer: FOA-100**  
**FIGURE 2**

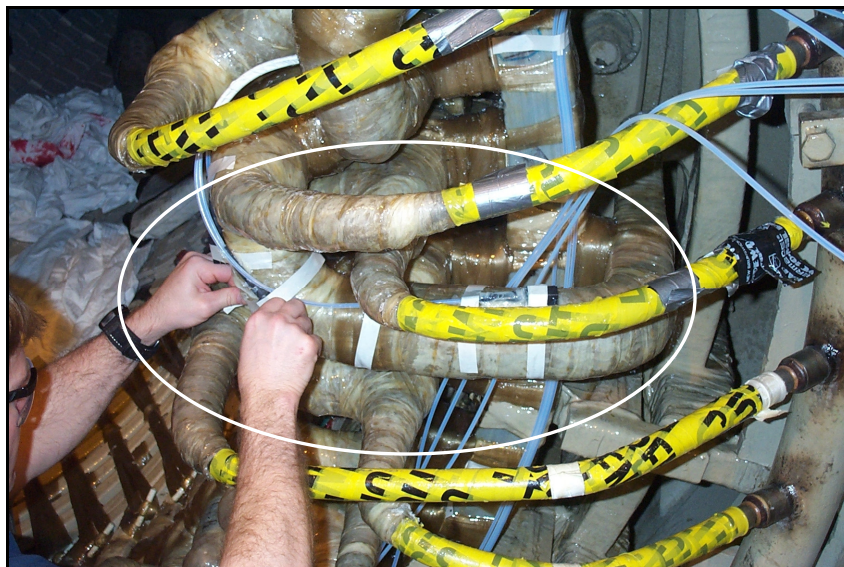
We can see in Figure 3 the actual installation of FOA accelerometers on the end-windings. As can be clearly seen, care must be taken when routing the fiber optic cable to prevent damage.

**Use of adhesive tape to hold FOA accelerometers sensors**  
**FIGURE 3**

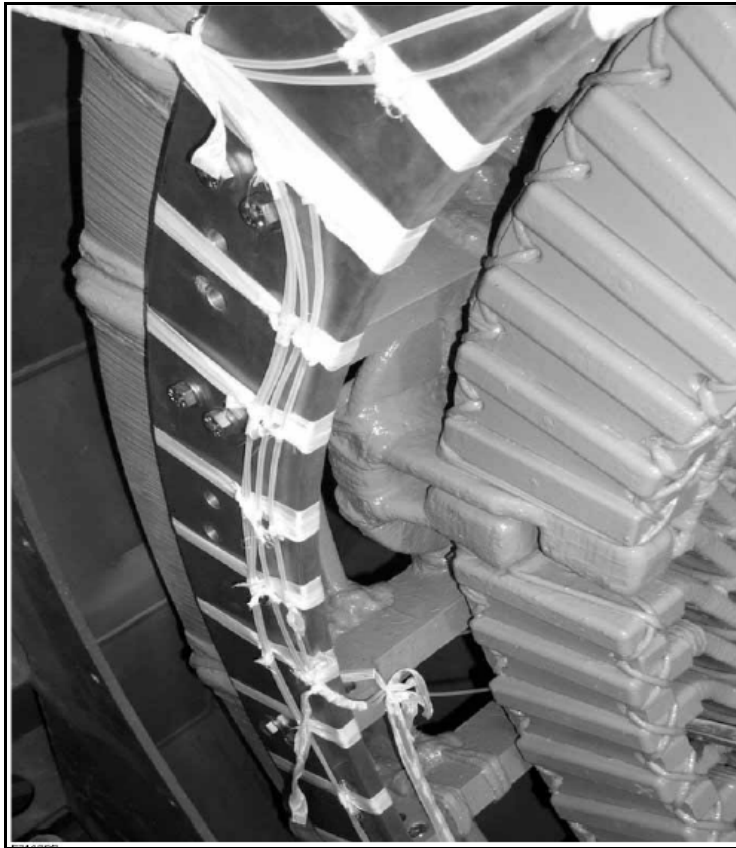
We can see in Figures 5 & 6 the routing and fastening of the fiber optic cables. These cables are usually fastened together and then exit the housing through penetration flanges.

**Other example of fiberglass ties and bundling of fiber optic cables**  
**FIGURE 6**

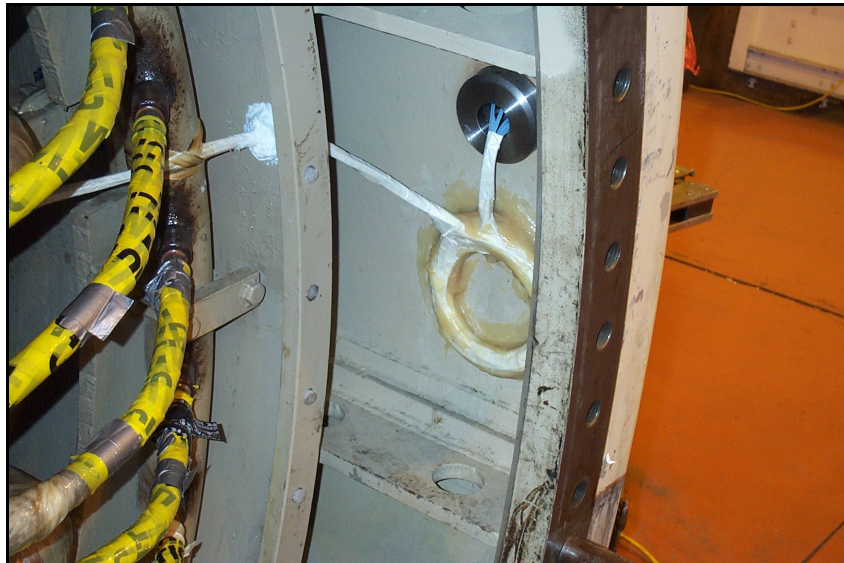
Figures 7& 8 shows the exit hole and penetration flange used in many cases to fasten the FOA conditioners. Extension cables are then connected to the conditioners for signal output.

**Managing excess cable in hydrogen-cooled turbo-generators**  
**FIGURE 7**

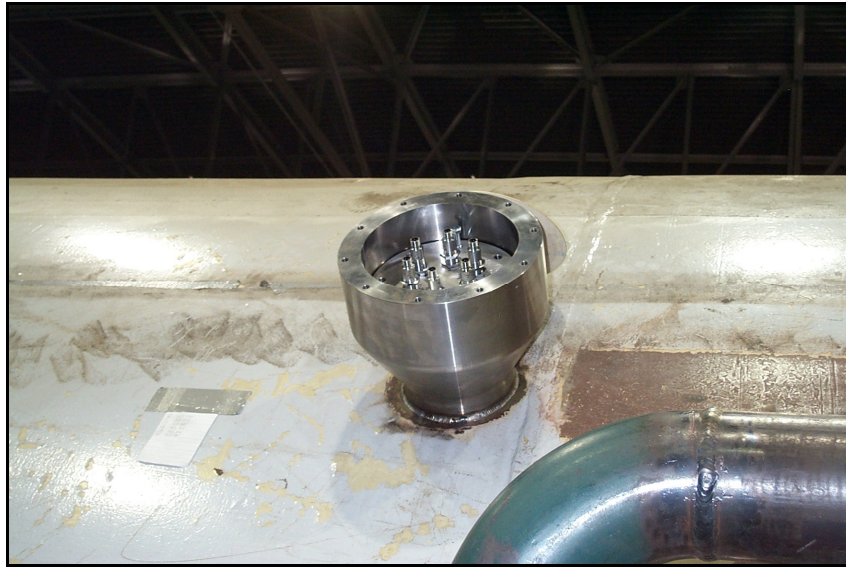
**Sealed flange with six conditioners installed**  
**FIGURE 8**
