# On-line Vibration and Temperature Direct Measurement on High Voltage Devices Using Fiber Optic Sensor Technology

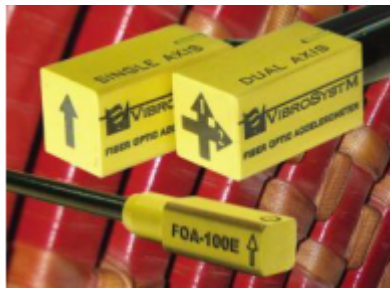
Figure 2 Fiber Optic Accelerometer: FOA-100, FOA-100E and FOA-200

Figure 2 is an example of the FOA accelerometer.
