## **Tidal Power Plant Bulb Unit Management Through Air Gap Monitoring**

**M. Jean-Louis Drommi**  
**Électricité de France**  
**France**

**M. André Tétreault**  
**VibroSystM Inc.**  
**Canada**

### **SUMMARY**

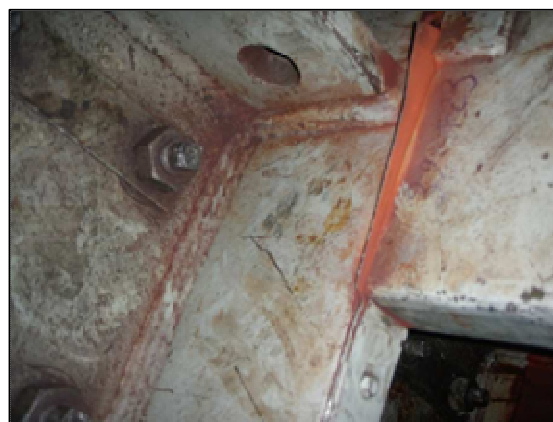
Fretting corrosion at rim/hub junction.

The first issue raised was fretting corrosion, which had been occurring at the shrink fit areas between the rim and the rotor hub, leading to shrink fit reduction (but without any possible quantification). The air gap monitoring system provided clear data so as to determine the actual situation in regards to the fretting of the rim.

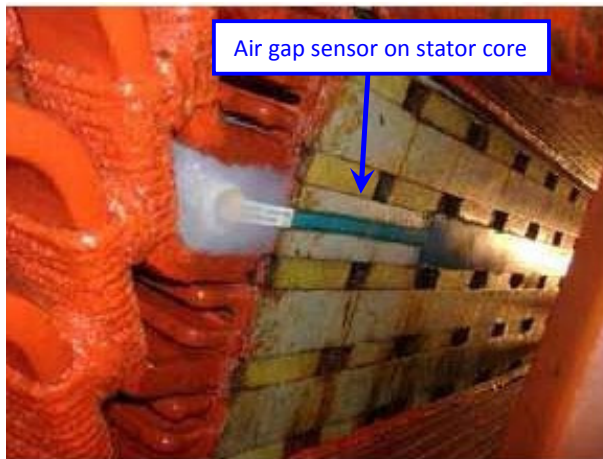
Air gap sensor glued to stator core.

- 6 capacitive air gap sensors selected for low air gap range; (sensor thickness 1,2mm ; measuring range : 1 to 10mm)
- 1 real time signal processing unit with 16 fast acquisition channels, used to collect air gap and additional dynamic data.
