On-line Condition Monitoring Solutions for JIRAU and SANTO ANTÔNIO Hydroelectric Projects

Authors: André Tétréault, Manager – Tests & Diagnostics Div., VibroSystM, Canada
Wellington Gomes, Representative – Brazil, VibroSystM, Canada

ABSTRACT

This paper will present the technologies supplied by VibroSystM to monitor the critical parameters of the SANTO ANTÔNIO and JIRAU generating bulb units, as well as a sample of cases detected on bulb units by VibroSystM monitoring technologies.

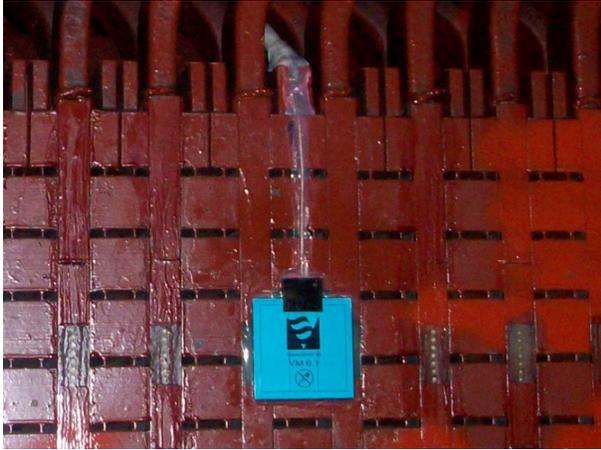
Fig. 12: VM 6 capacitive air gap sensor installed on a stator wall.

For air gap, four (4) VM6 capacitive sensors are installed 90° apart on the upstream side plane of the stator and 4 more on the downstream side. They are connected via 7m integral triaxial cables to eight (8) LIN-360 linearization modules, and their 4-20mA signal outputs are transmitted to the acquisition unit. The VM6 sensor small footprint blocks the smallest amount of ventilation holes while measuring air gap up to 50 mm.

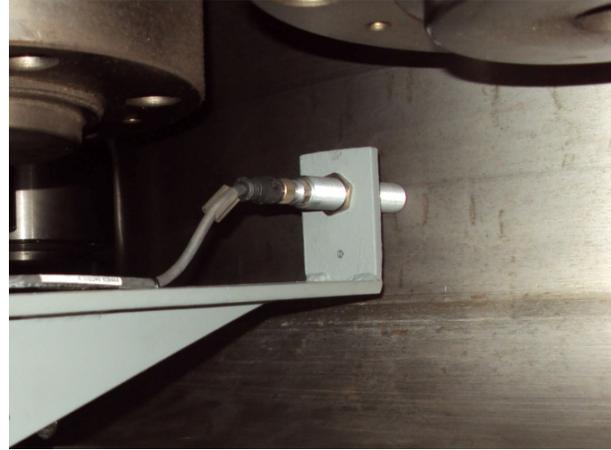
Fig. 13: PCS-302 capacitive proximity sensor facing a hydrogenerator shaft.

For shaft displacement, two (2) PCS-302 capacitive proximity probes are being installed 90° apart on each of the two guide bearings to measure radial relative displacement. For axial shaft displacement, the SANTO ANTÔNIO bulbs are equipped with one (1) PCS-304 probe at the combined guide and thrust bearing near the generator, while the JIRAU bulbs are fitted with two (2) PCS-302 probes at the same location. Capacitive proximity probes have been specified because of their immunity to electrical runout (residual magnetism, shaft current, material type, surface finish) and built-in signal conditioners allowing direct connection of the probes to the acquisition unit without need to mount probe drivers inside the bulb.

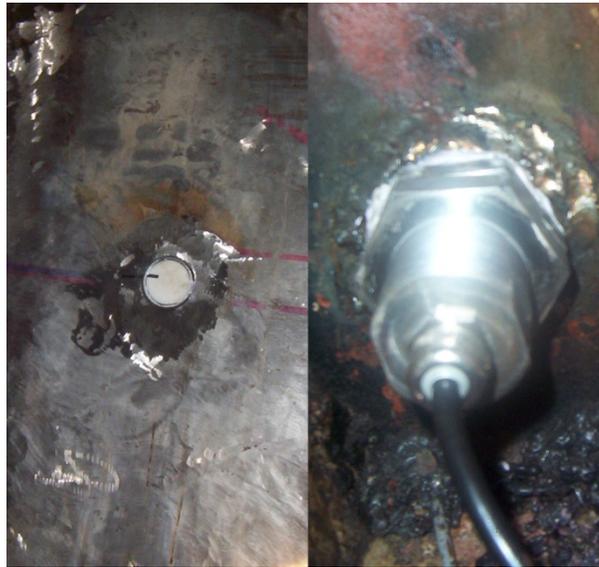
Figure 14: Front (inside) and back views of an installed SPES-117 sensor in the throat ring.

For JIRAU bulbs, the turbines are fitted with four (4) SPES-117 submersible proximity probes mounted 90° apart in the turbine liner at the level of the blade tips. The probes are connected to marshalling boxes mounted in the turbine access shaft and the signals are then transmitted to the acquisition unit.

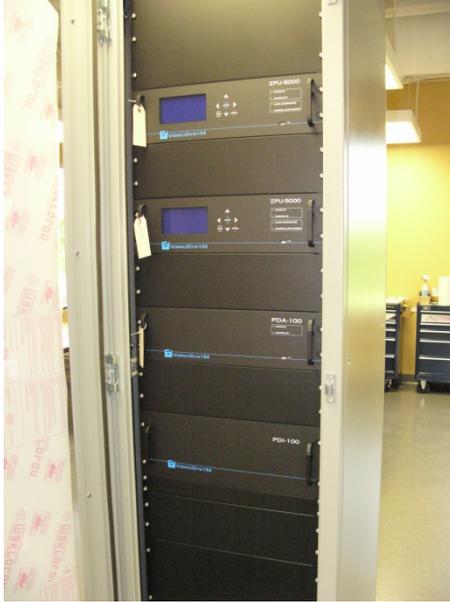
Fig. 15: Front view of Santo Antônio cabinet.

The instrumentation cabinets housing the data acquisition units, power supplies, protection relays and Ethernet communication devices are located near the generator access shaft of each bulb units. Data is acquired via two (2) ZPU-5000 multi-channel monitor for a capability of up to 32 inputs. It continuously processes signals from each input and monitors them for alarms, it performs different types of automatic and on-demand measurements, and transmits data to the system controller via the dedicated Ethernet network. When an alarm is detected, the ZPU-5000 triggers the corresponding dry contact relay which is connected to the control system. A measurement is recorded and a warning message is transmitted through the network to all connected users. For partial discharge monitoring at SANTO ANTÔNIO, signals from the couplers are connected to a PDI-100 interface unit and to a PDA-100 analyzer unit, then transmitted to the system controller via the same Ethernet network. The cabinets are equipped for redundant DC voltage inputs with breakers and undervoltage relays to notify of power input failure on one of the power source. They also include ventilation system to avoid excess temperature and heaters against humidity.

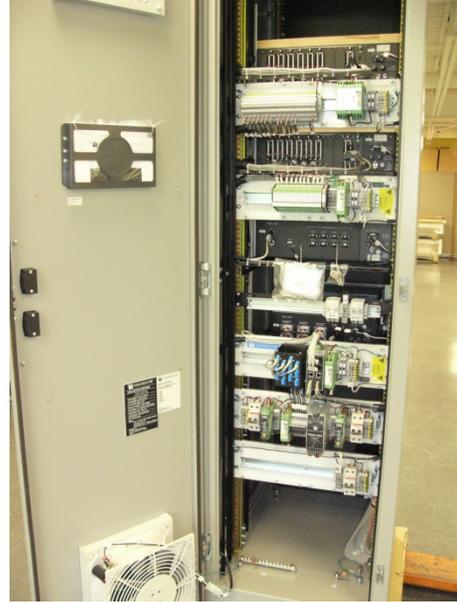
Fig. 16: Rear view of cabinet.

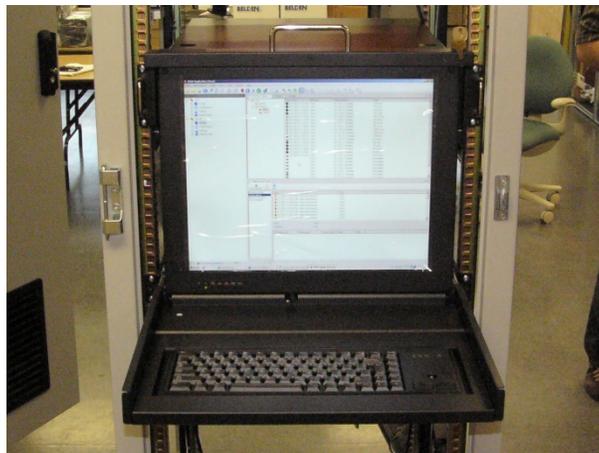
Figure 17: One of Jirau rackmount controller.

The system at each plant will be managed by a distributed network of system controllers (server-grade computer) in each powerhouse, i.e. four (4) controllers at SANTO ANTÔNIO and four (4) at JIRAU. This is required because the way the powerhouses are being built and put into service, as well as to ensure performance and overall reliability to avoid overburdening the processors. Each system controllers will manage a set of acquisition units through the ZOOM dedicated Ethernet fiber-optic network, and store database. In addition, each controller will be interfaced with the SDSC system to collect valuable complementary information about its set of machines for trending and correlation. A human-machine interface (HMI) workstation (desktop computer), located in the control room of each power plant, will serve to display the monitoring status of any machine, annunciate alarm conditions and provide access to the various databases for analysis. Additionally, data from each plant could be accessed remotely via corporate WAN network by companies' engineers and decision makers from the head office or anywhere in Brazil.

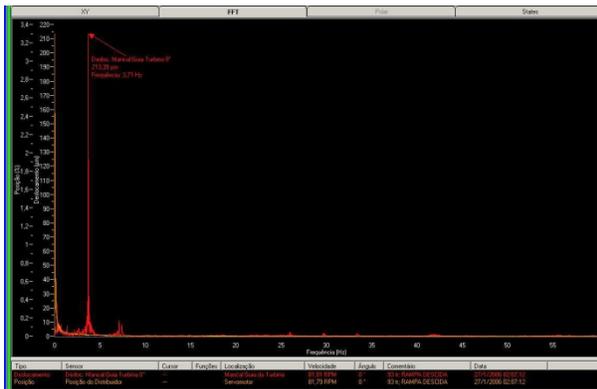
Fig. 20: Sample of spectrum graph.

The ZOOM software analysis features include: polar view of the generator rotor inside the stator referenced to tolerances, polar view of the turbine blade tips inside the throat ring, shaft orbit view referenced to the rotor pole angular positions, FFT, scatter plots and waveforms of partial discharges, and trends just to name a few.
